**REPORT OF TEST ON**

**MATED CONNECTORS**

**RAIN TEST**

**AMPHENOL AEROSPACE**

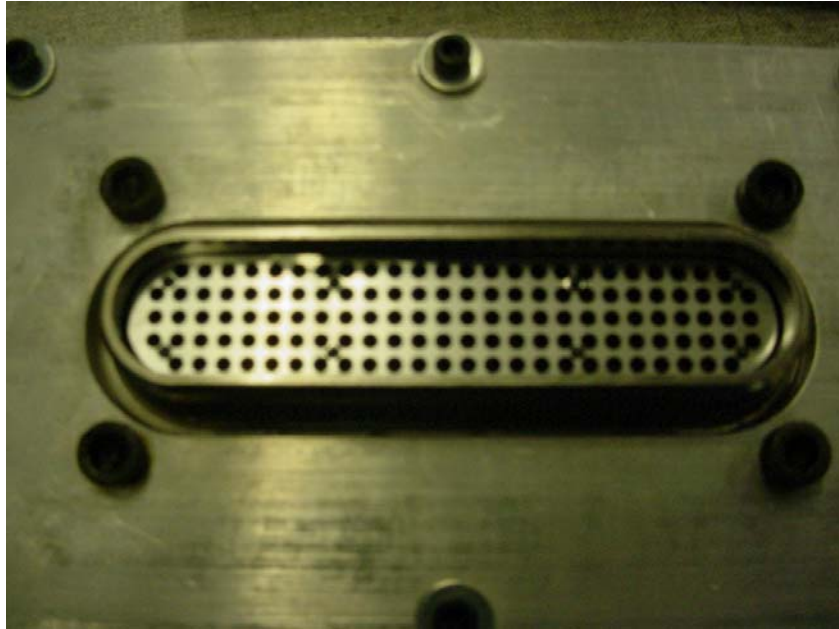
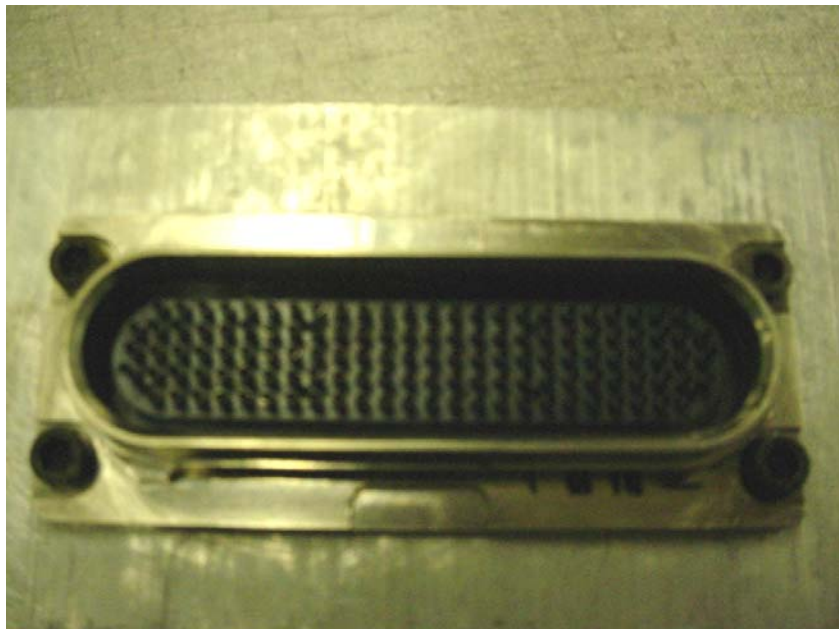
Figure 2  
1.5K Connector

The connector pairs completed the rain test with no evidence of external damage. In addition, the connector pairs exhibited no evidence of water penetration inside the connectors.
