**REPORT OF TEST ON**

**MATED CONNECTORS**

**RAIN TEST**

**AMPHENOL AEROSPACE**

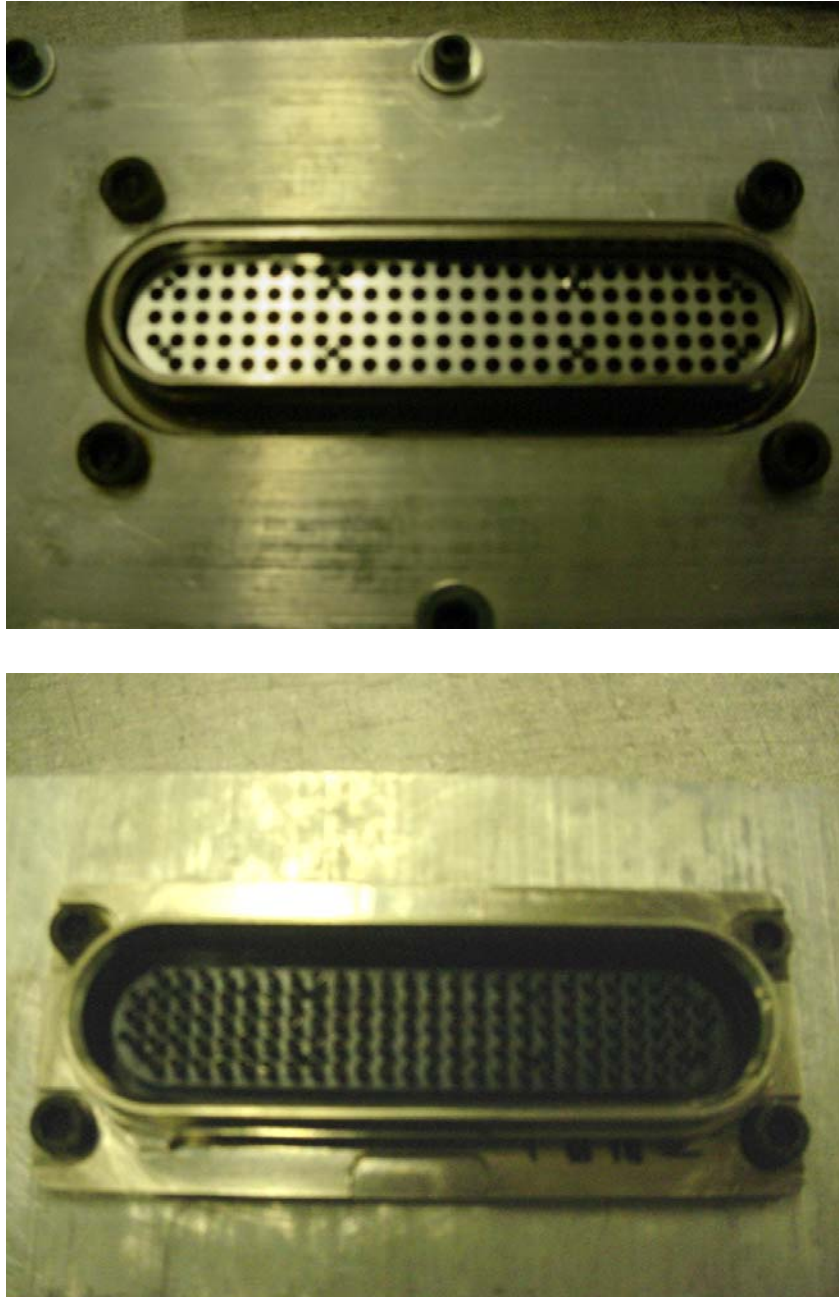
Figure 2  
1.5K Connector

The connector pairs completed the rain test with no evidence of external damage. In addition, the connector pairs exhibited no evidence of water penetration inside the connectors.
