Aerospace Operations 40-60 Delaware St. Sidney, NY 13838-1395		MOLDING	Manufacturing Layout Part No.
Quality Approval: HANEY Page 24	Quality Standards		<b>PR302 ISM</b>  Revision 8/09/2012
	In Shell Molding ISM

### Background:

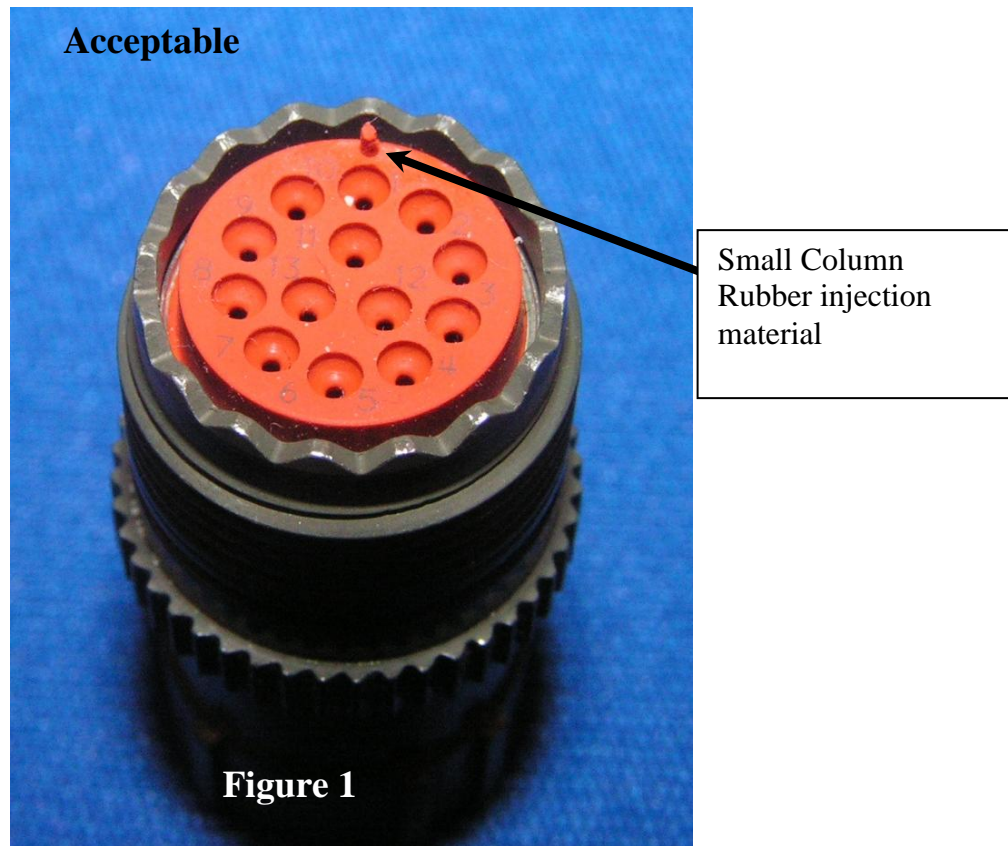
- The Integrally Molded manufacturing method appearance differs from the previous manufacturing method as follows:
  1. At the wire sealing grommet, accessory end of the connector, a small column of the fluorinated silicone rubber will be located on the rear surface near the top of the insert pattern. This is the point of rubber injection (See Figure 1). This is cosmetic and has no effect on the connector form, fit, or function.

**Photos of various conditions. (Acceptable and Unacceptable are shown).**

See Page 24H for further details pertaining to the rubber column.

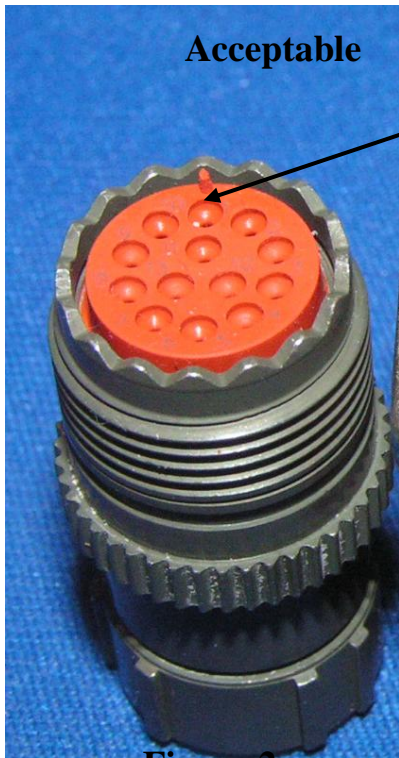
**Figure 2**

2. The diameter between the fluorinated silicone rubber grommet and the metal shell inside diameter will not have a clear RTV backfill (See Figure 2). A separate backfill operation is not required for this “integral molded” design.

Molded rubber seal

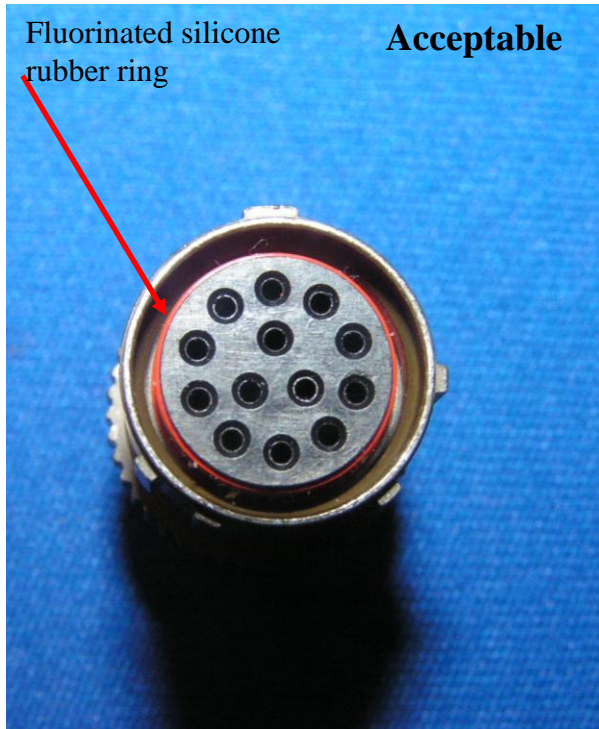
**Figure 3**

3. The diameter at the mating end of a plug with socket contacts will have a ring of fluorinated silicone rubber around the insert periphery. This is cosmetic and has no effect on the connector form, fit, or function.  
(See Figures 3 and 6 for Acceptable)

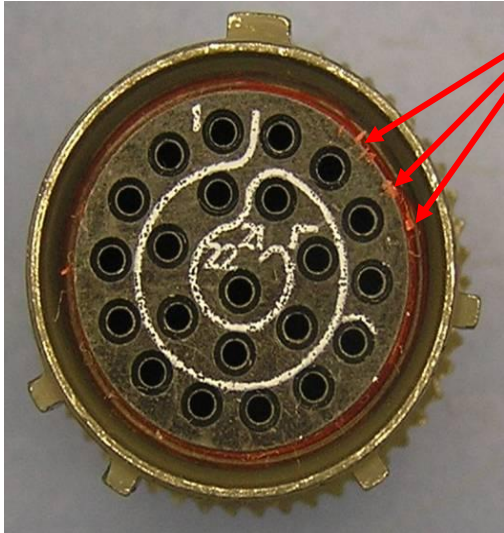
Figure 4

Loose matter / flash  
from Molding.

**Reject**

4. Loose flash or free ‘floating’ pieces of molding material or other FOD is Not allowed. (See Figures 4, 5, 9, 10, 11, 12).

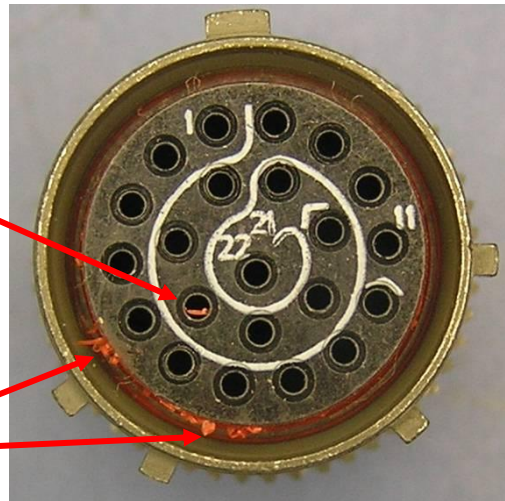
Figure 5

Loose  
matter from  
Molding.

Loose Flash

**Reject**

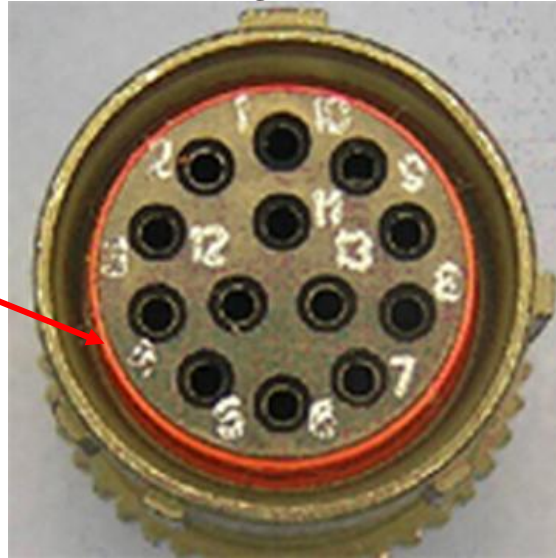
**Figure 6**

Ring of Molding material around insert exhibits no flash or loose matter.

**Acceptable**

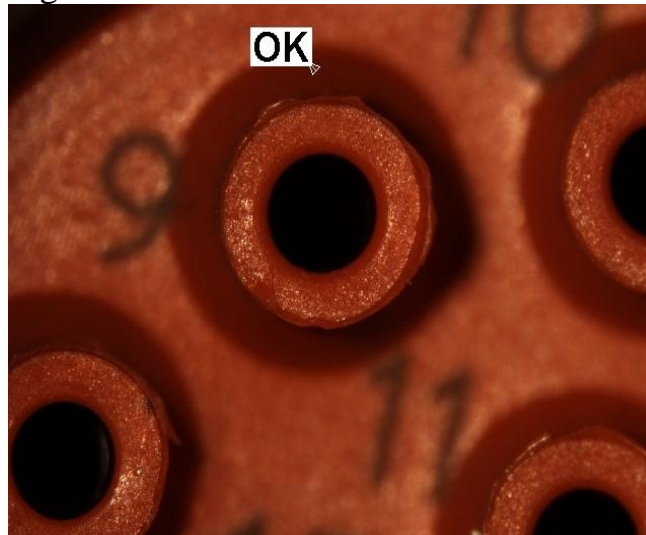
Figure 7

Solidly attached flash on outside of towers is ACCEPTABLE, (Figure 7 and 8), IF it does not and can not invade the contact hole.

**Acceptable**

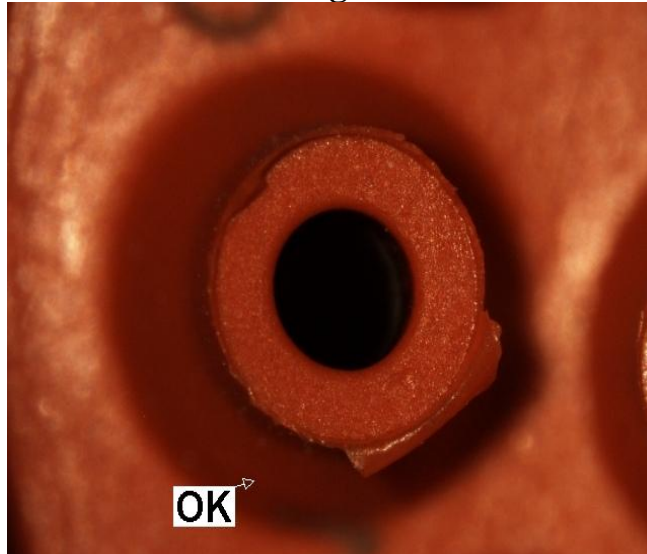
**Figure 8**

**ACCEPTABLE**

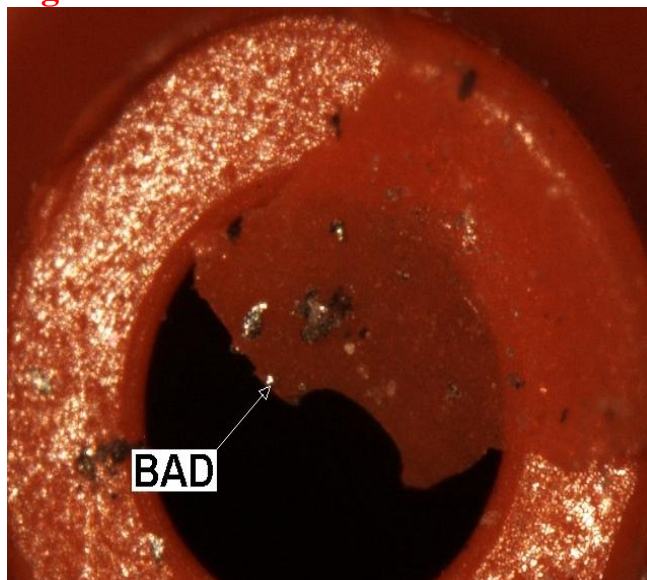
**Figure 9**

**UNACCEPTABLE FLASH** is shown on **Figures 9,10,11,12.**

Thin and loosely attached flash which may break off is not permissible.

**REJECT**

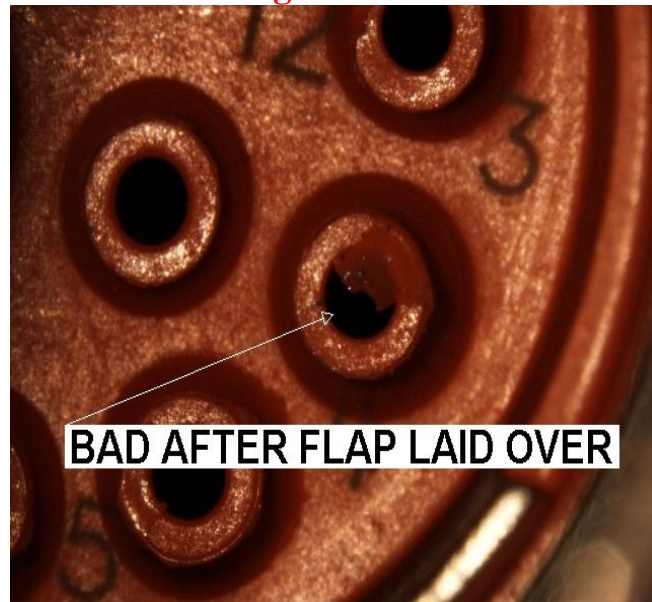
**Figure 10**

**REJECT**

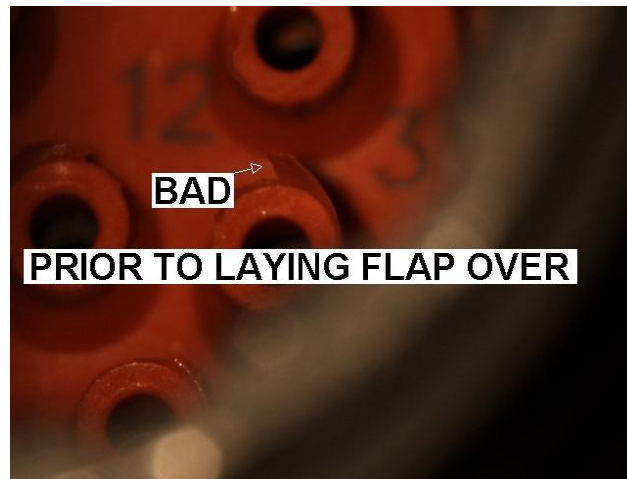
**FIGURE 11**

**REJECT**

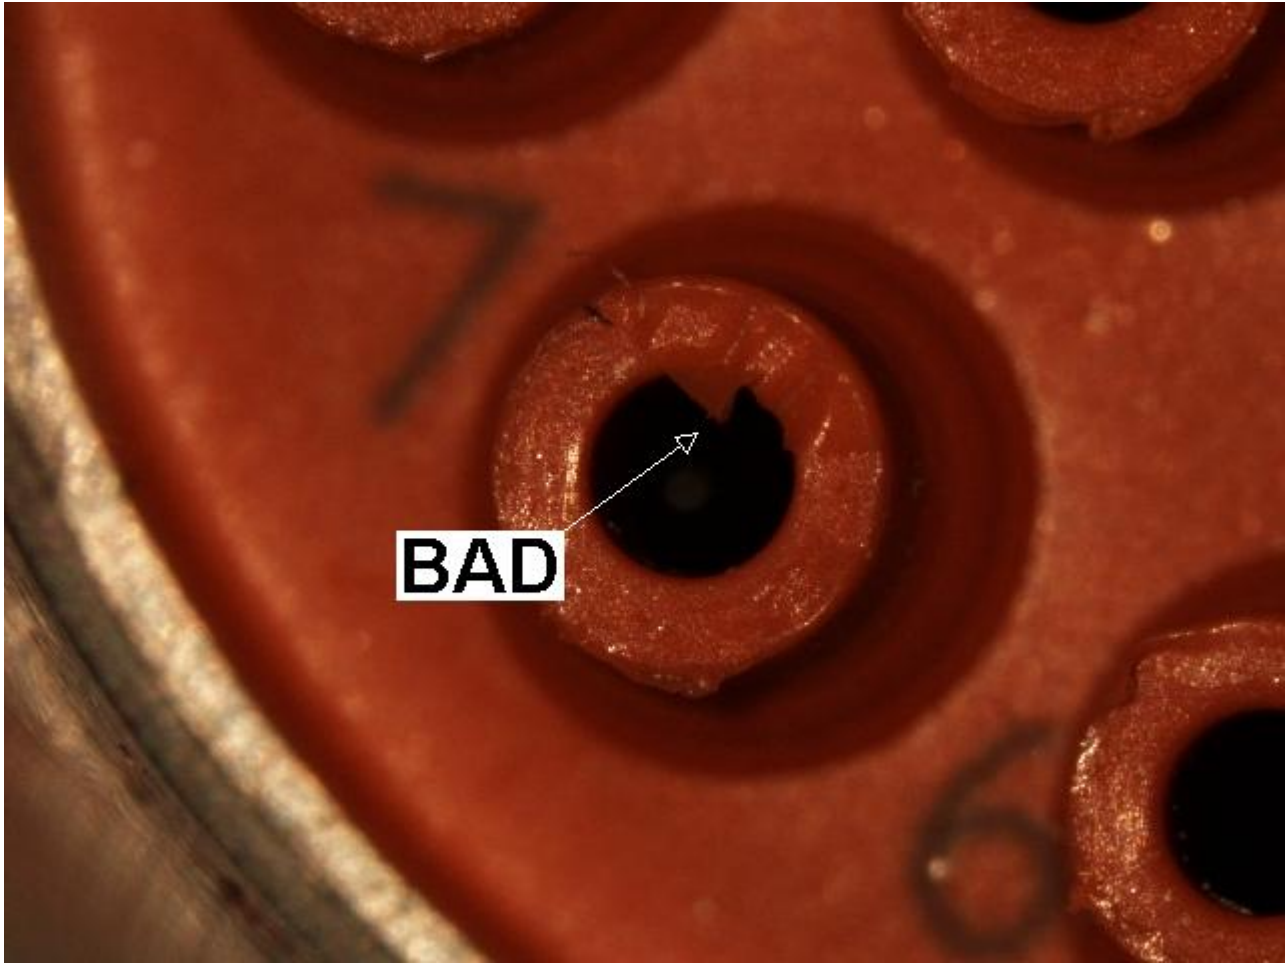
**FIGURE 12**

**REJECT**

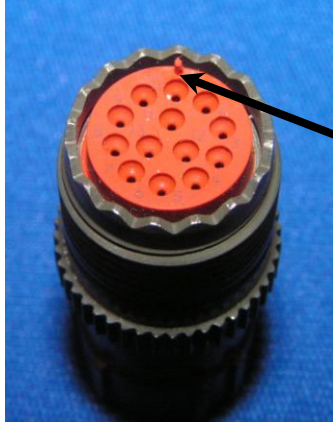
The small column of rubber injection material may not always appear 'perfect' as shown to the right. The 2 photos below show acceptable product, the 'column' does not modify the outside diameter of the grommet. The bottom 2 photos show Unacceptable product, as the column does modify the diameter of the grommet.

Small Column  
Rubber injection  
material

**Acceptable rubber columns ( above and two immediate below)**

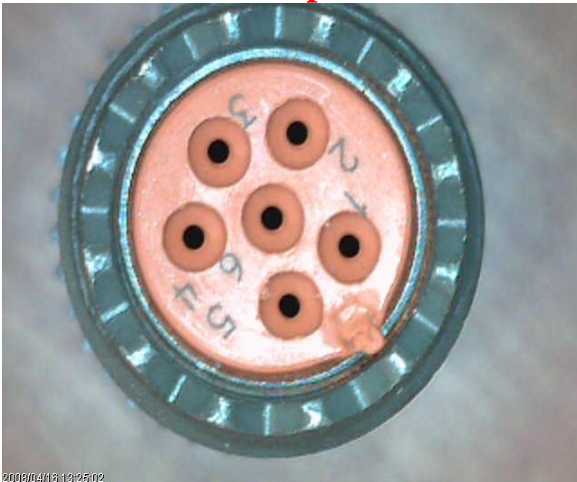
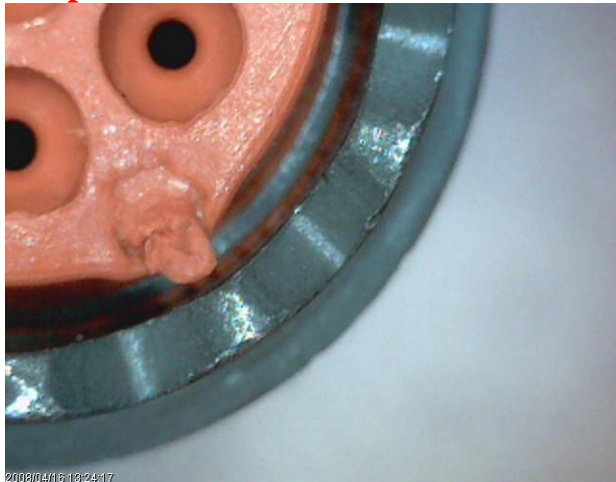
**Two photos below show unacceptable rubber columns**

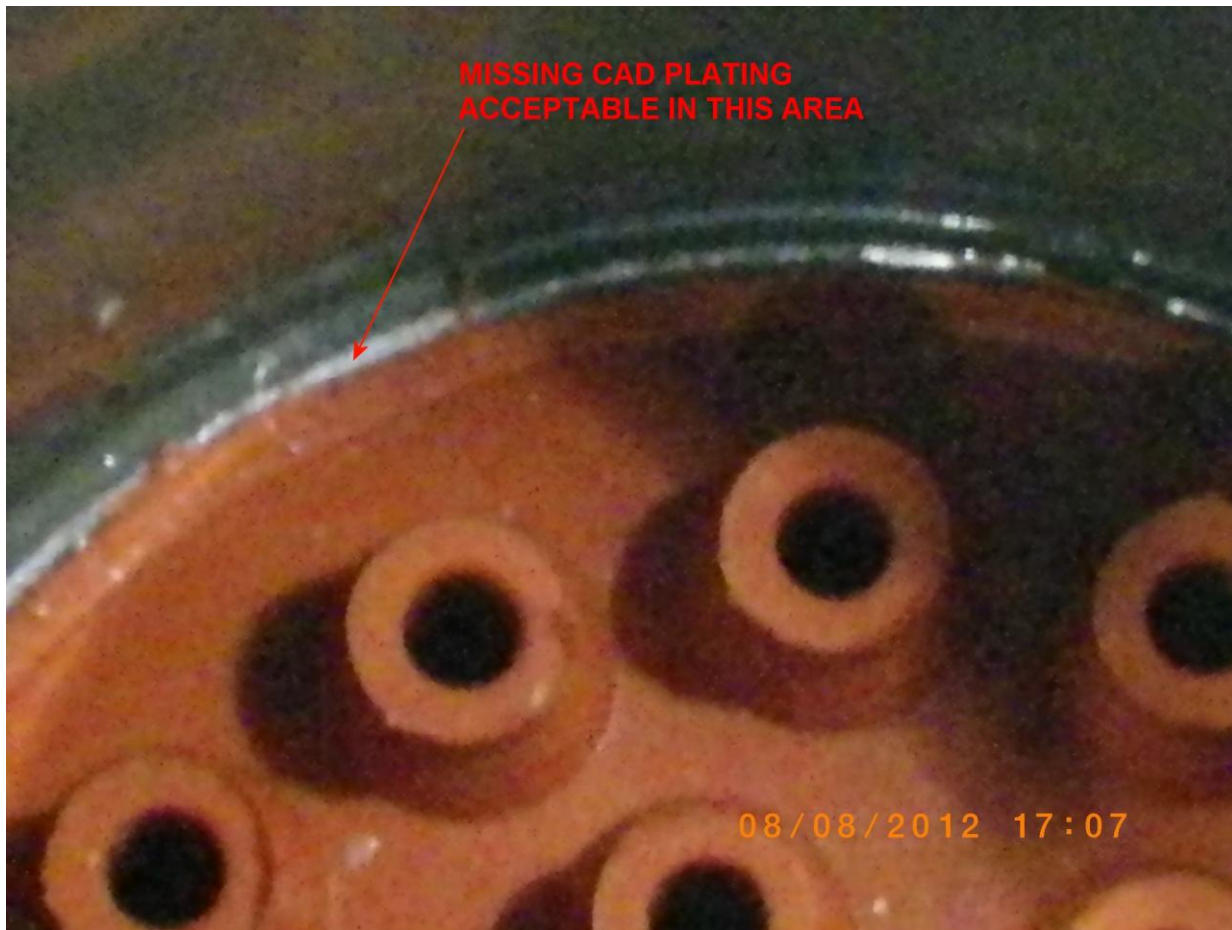
It is normal for the Chromate to be removed due to closing the mold against this surface.  
The actual Cadmium plate underneath is still present.  
This condition is ACCEPTABLE.
