ENGINEERING REPORT	Report #	CE23-0606
	EWOM #	N/A
	CLT #	10825
Evaluation of R-VPX product to VITA 72 vibration levels	Revision #:	A
	Publish Date	
	6/19/2023

Testing was performed on Amphenol's R-VPX Ruggedized VITA 46 connector to determine its ability to withstand VITA 72 vibration levels.

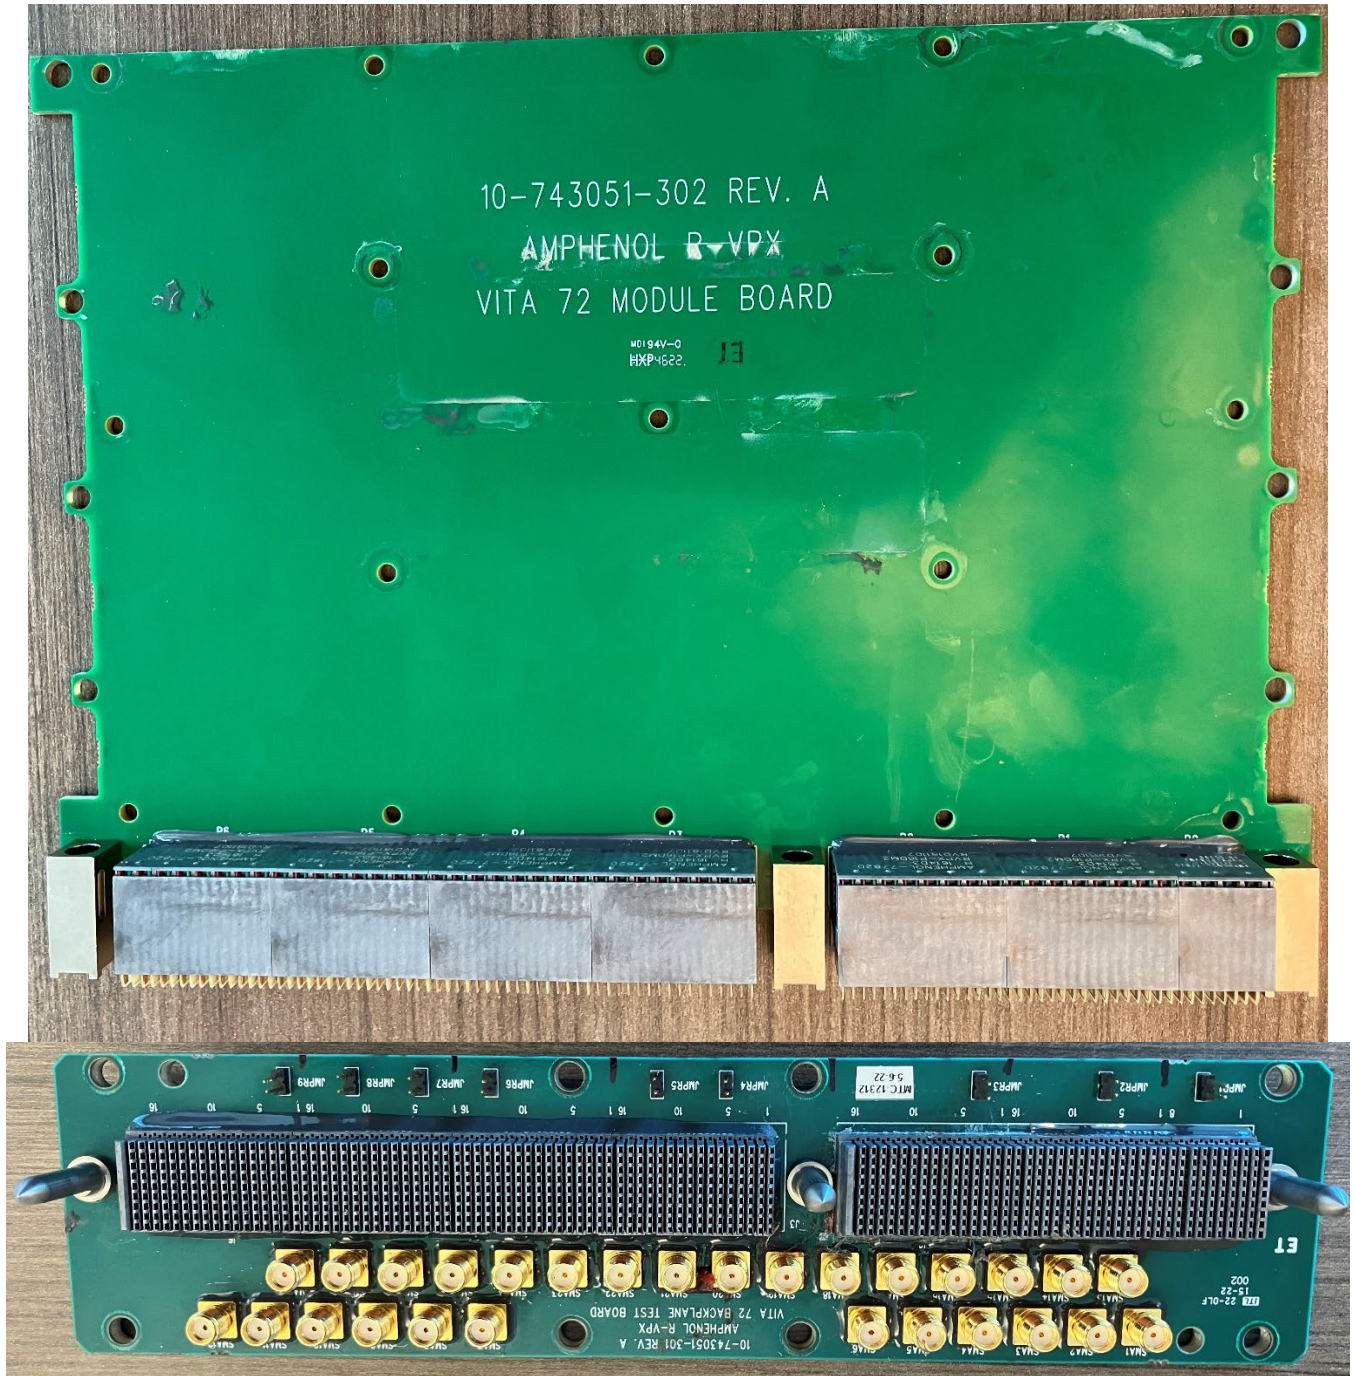
Figure 1: Typical Test Sample

Test specimens were taken from normal production lots. Specimens identified with the following part numbers were used for test. Testing was performed on 50 µin gold parts.

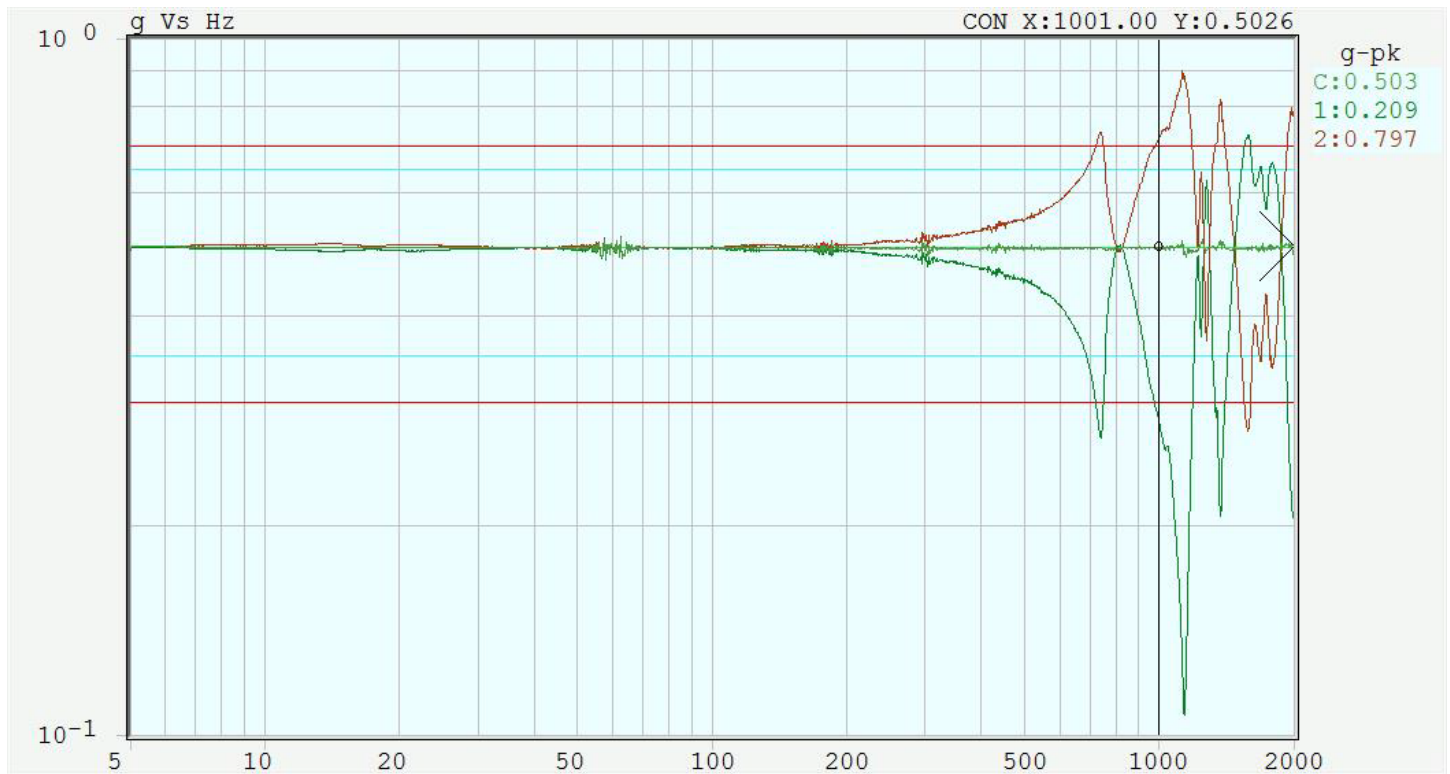
Figure 4: Frequency response Z axis

Figure 4 shows the sine sweep response for the Z axis. This response shows that the system is relatively inline with typical natural frequency of 6U chassis. See appendix A for remaining frequency response graphs from each axis of test.

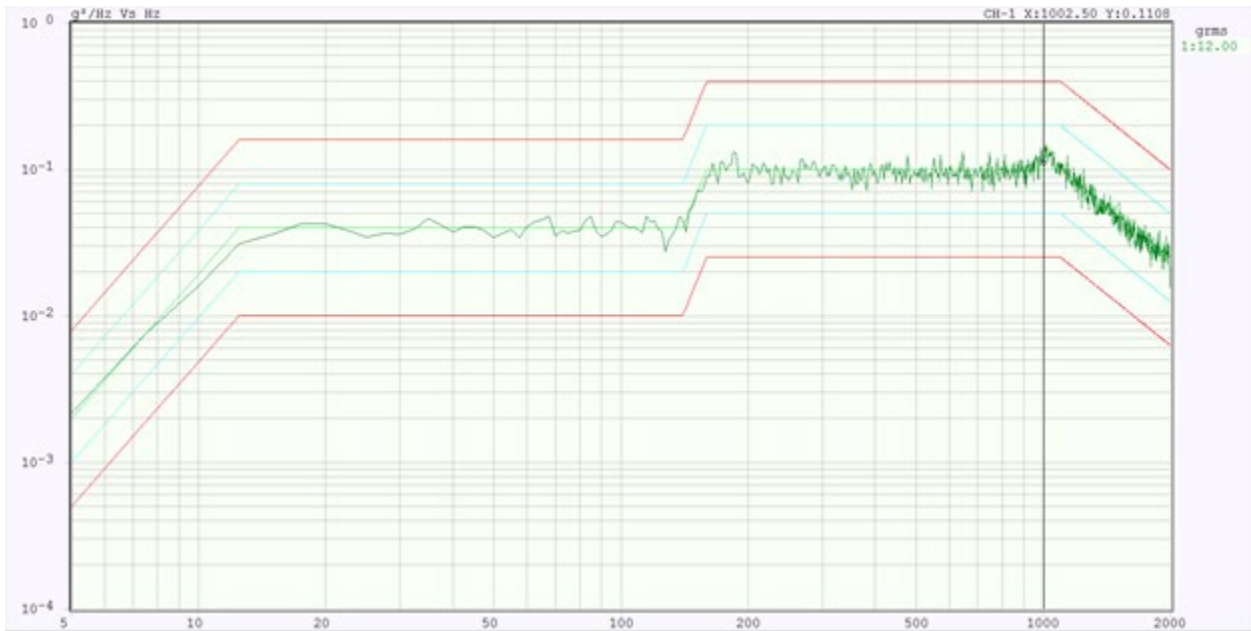
Test Profile								
Freq. Hz	Velocit y In/Sec	Displace. In D.A.	Acceler. G Pk	PSD G ² /Hz	Overall G RMS	Roll Up dB/Oct	Roll Off dB/Oct	Remarks
5				.002				
13				.04				
140				.04				
160				.1				
1100				.1				
2000				.025

Random

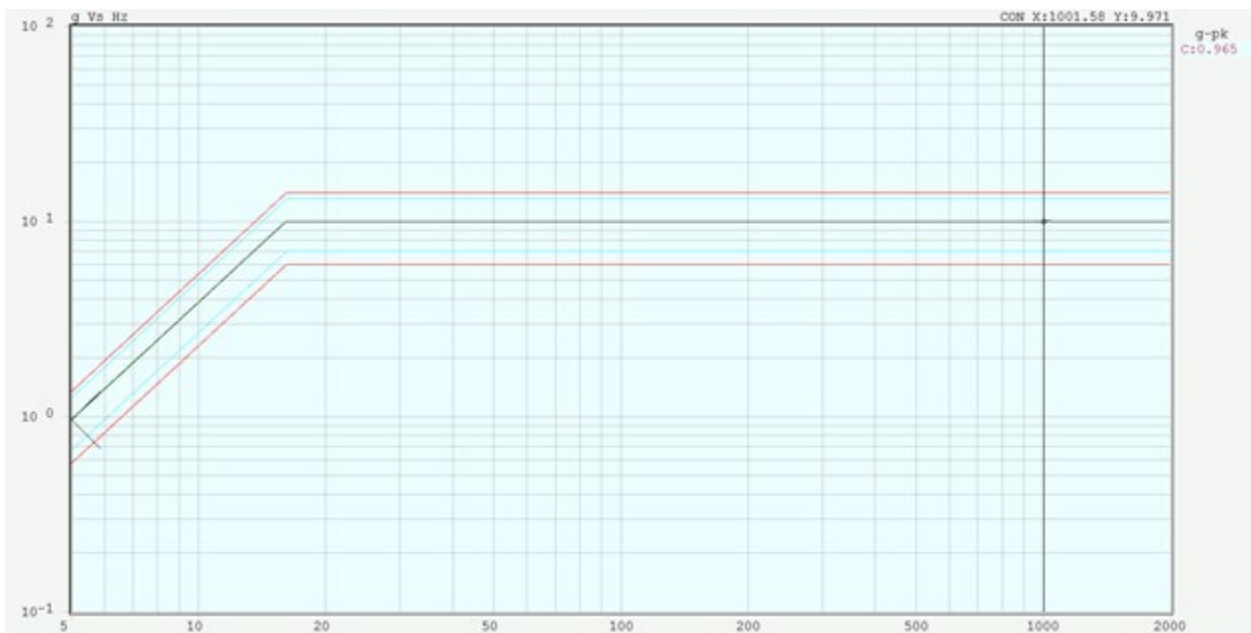
Test Profile								
Freq. Hz	Velocit y In/Sec	Displace In D.A.	Acceler G Pk	PSD G ² /Hz	Overall G RMS	Roll Up dB/Oct	Roll Off dB/Oct	Remarks
5			.95					
15			8.628					
16			10					
2000			10

Sine

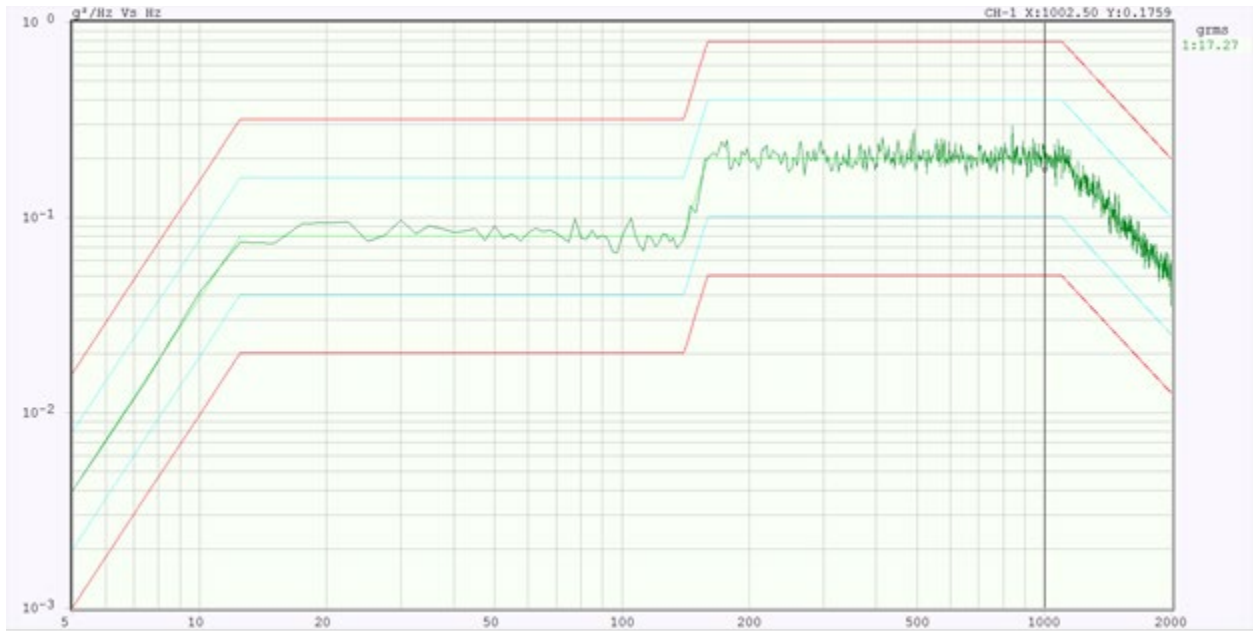
Random +3dB

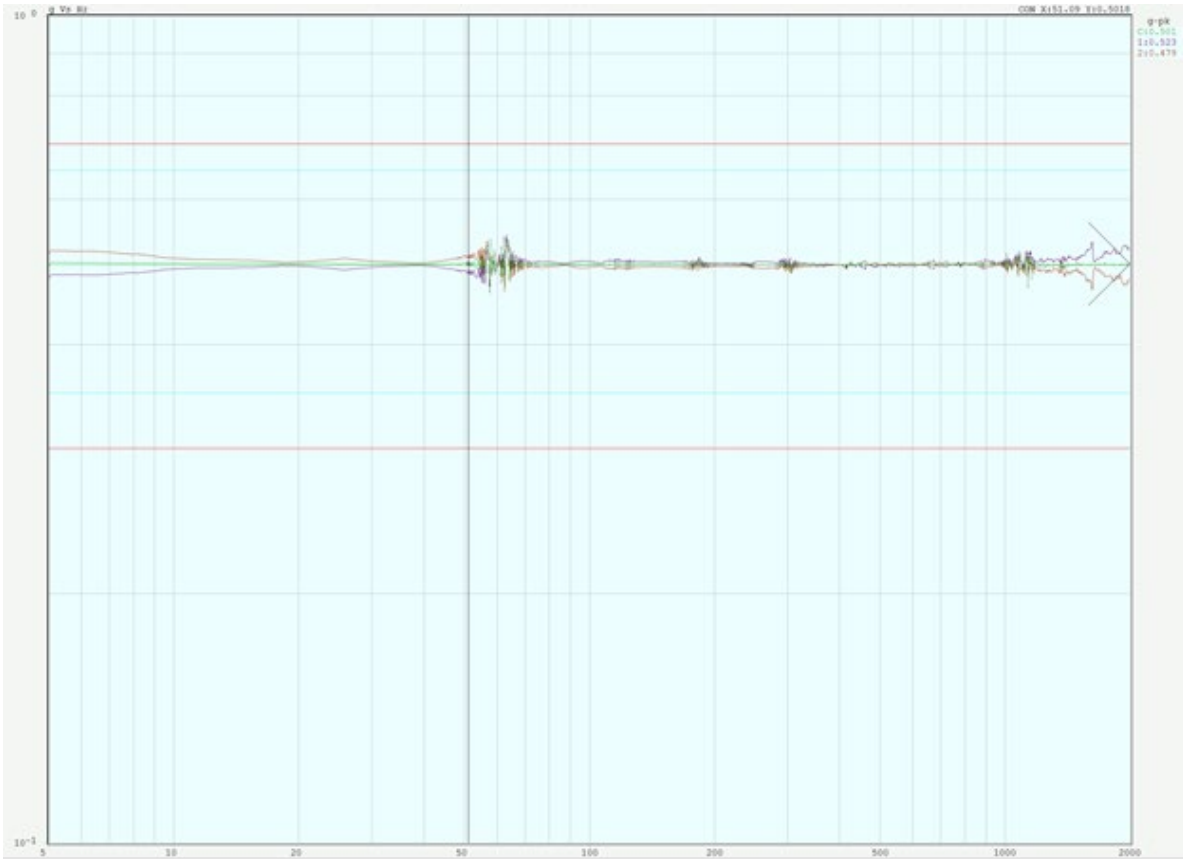
X axis sine sweep with fixture and backplane

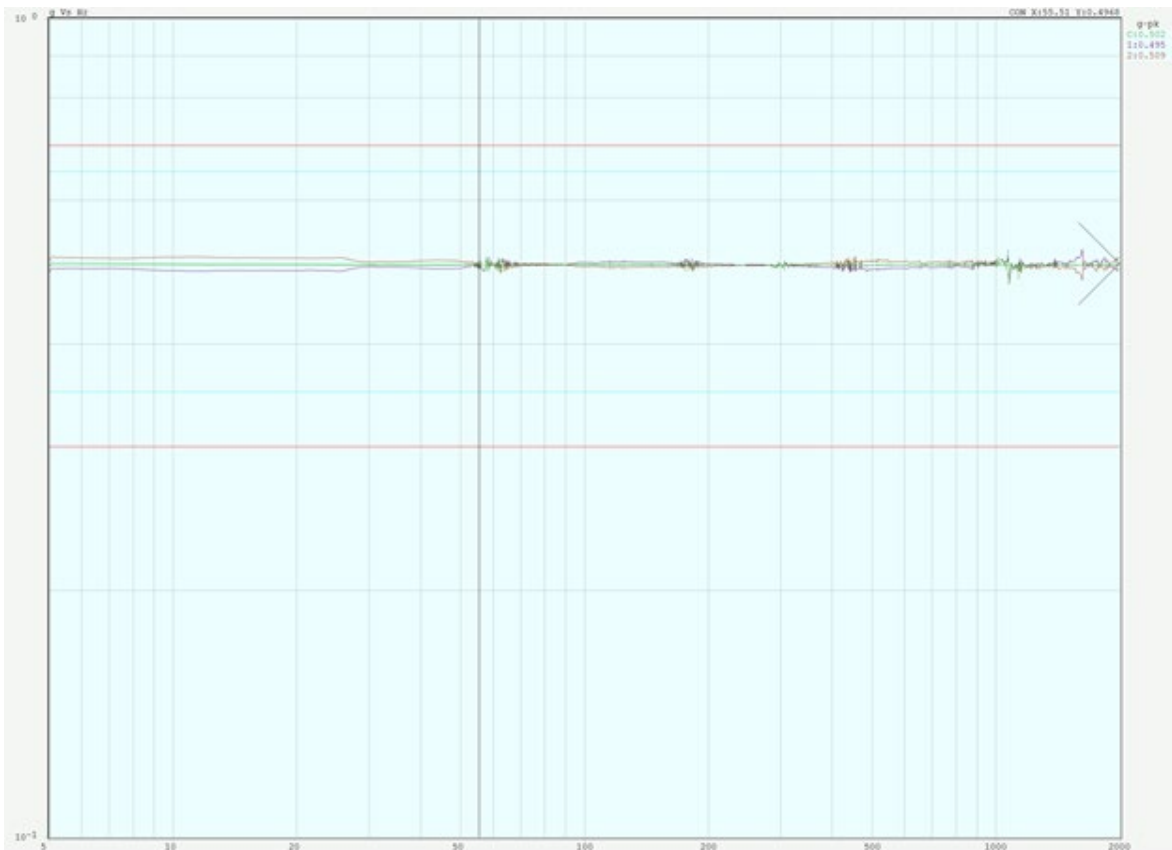
X axis Sine Sweep, Fixture, backplane and cables

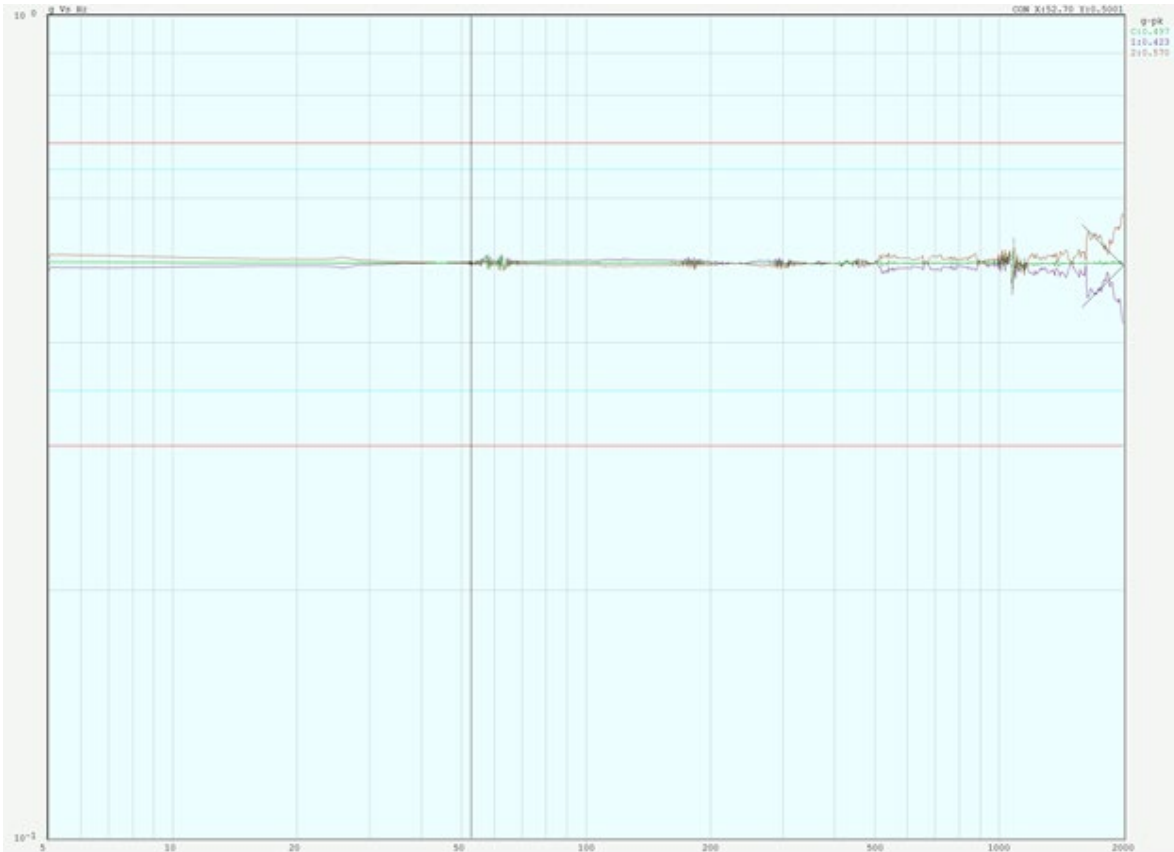
X axis Sine Sweep Whole assembly

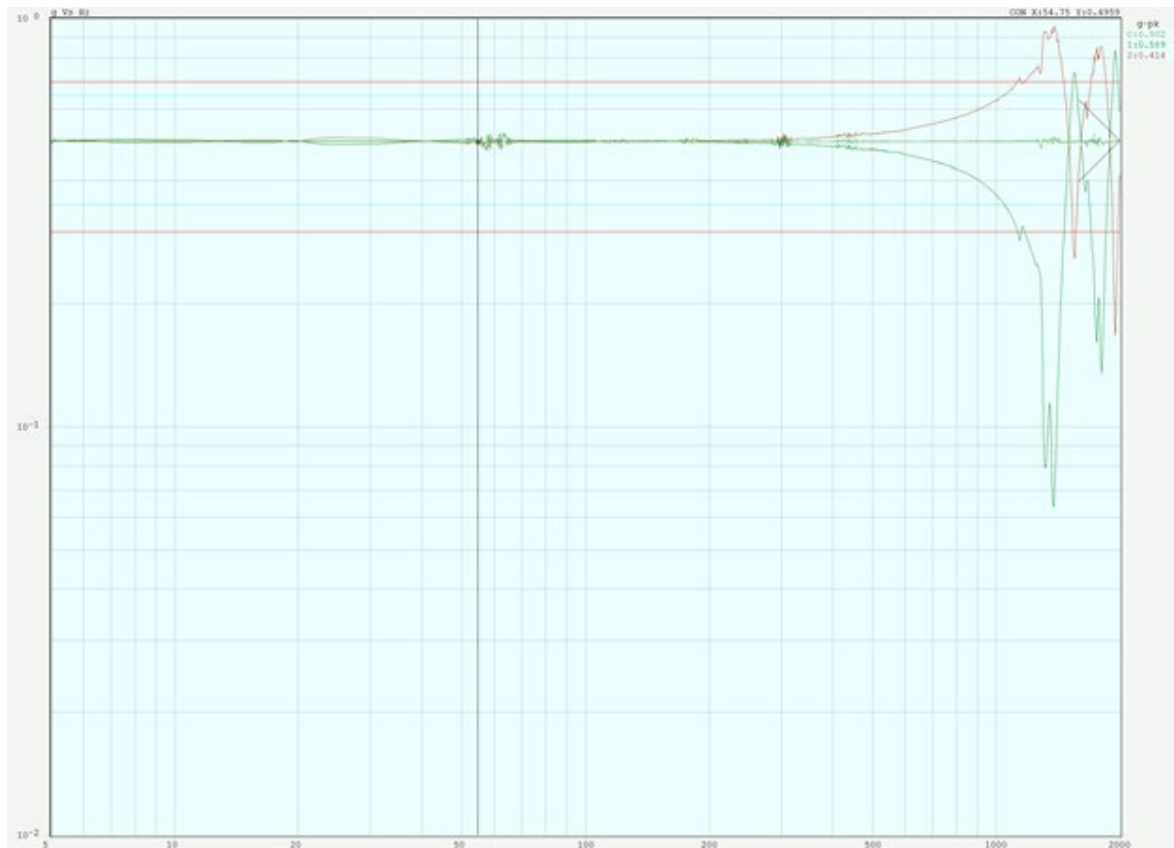
Z axis sine sweep with just the fixture

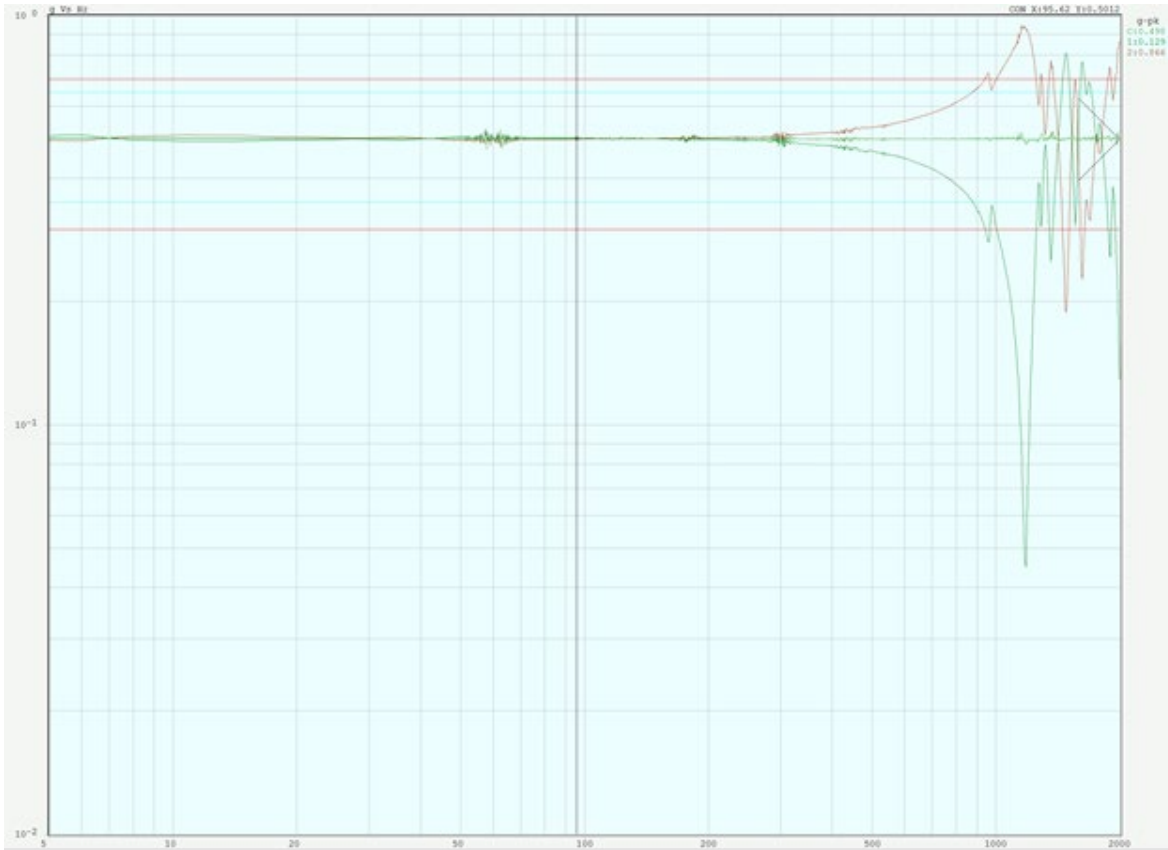
Z axis Sine Sweep with fixture and backplane

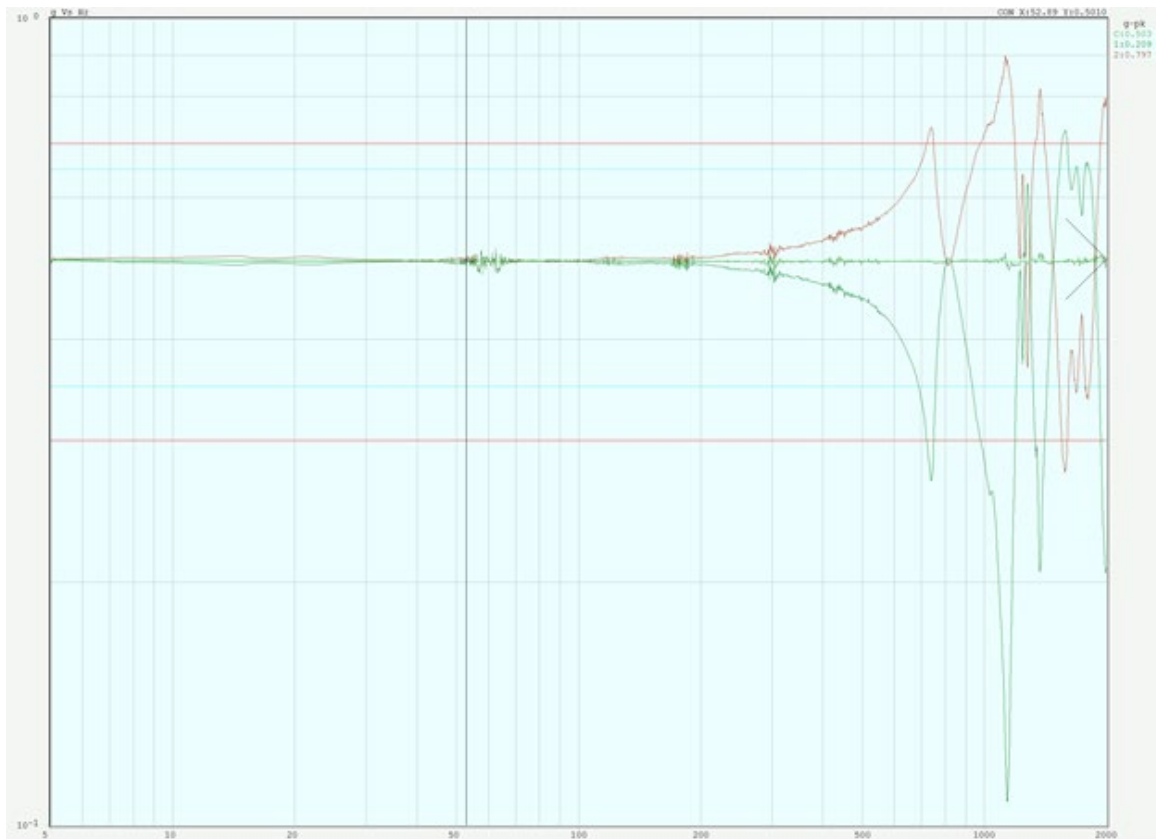
Z axis sine sweep fixture, backplane and cables

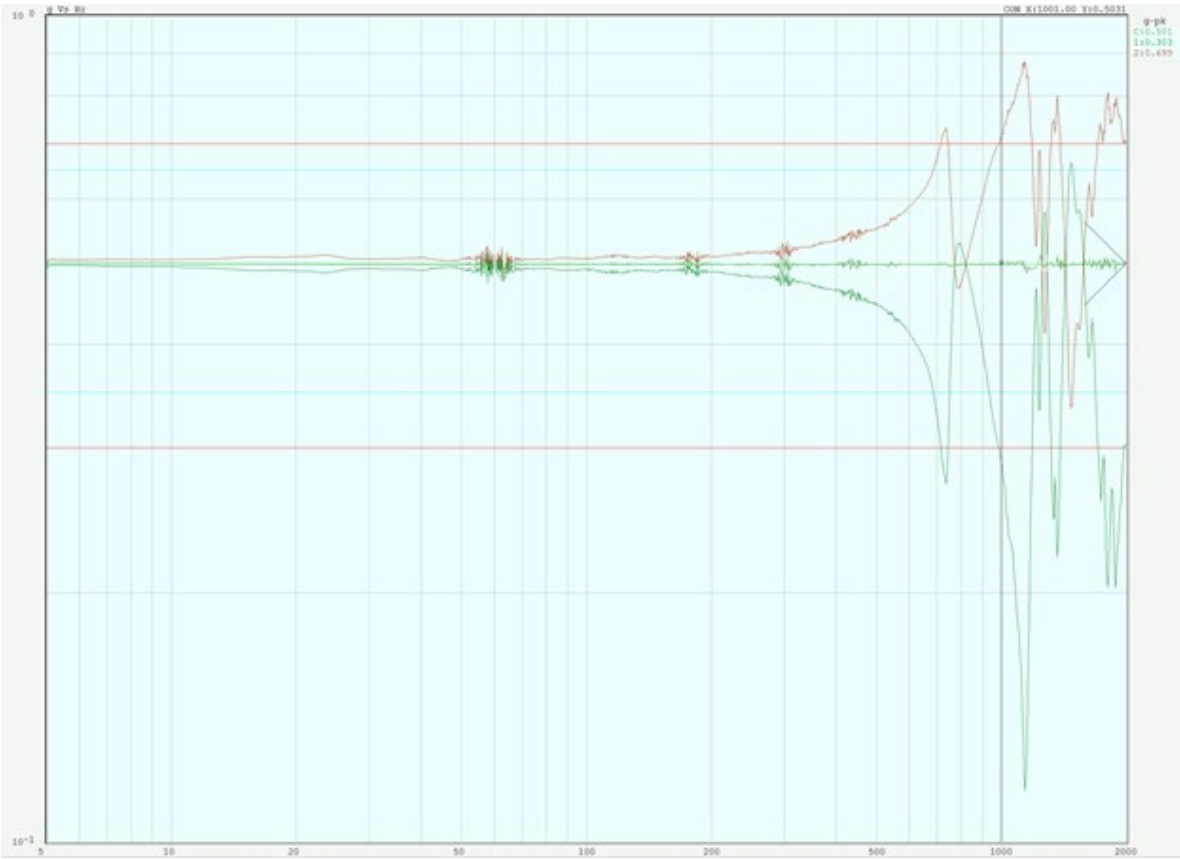
Z axis with whole assembly

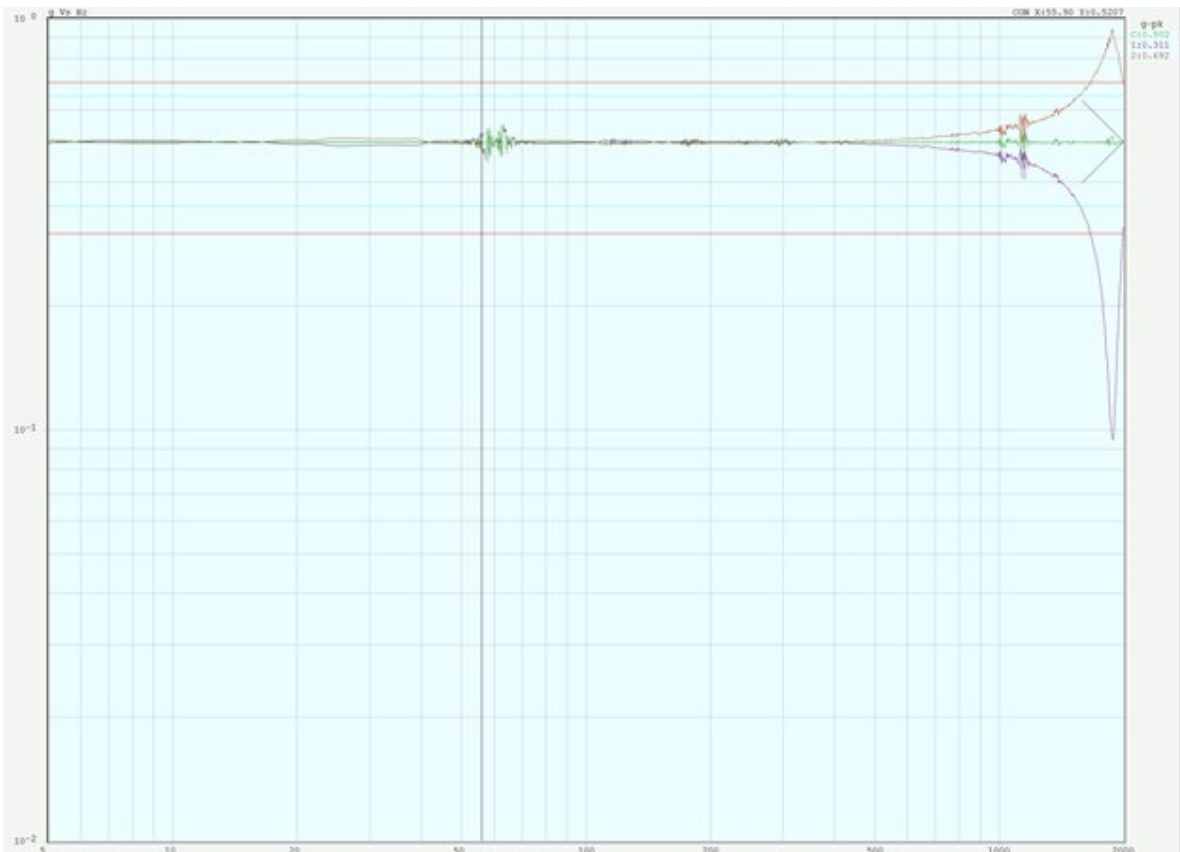
Y axis sine sweep bare fixture

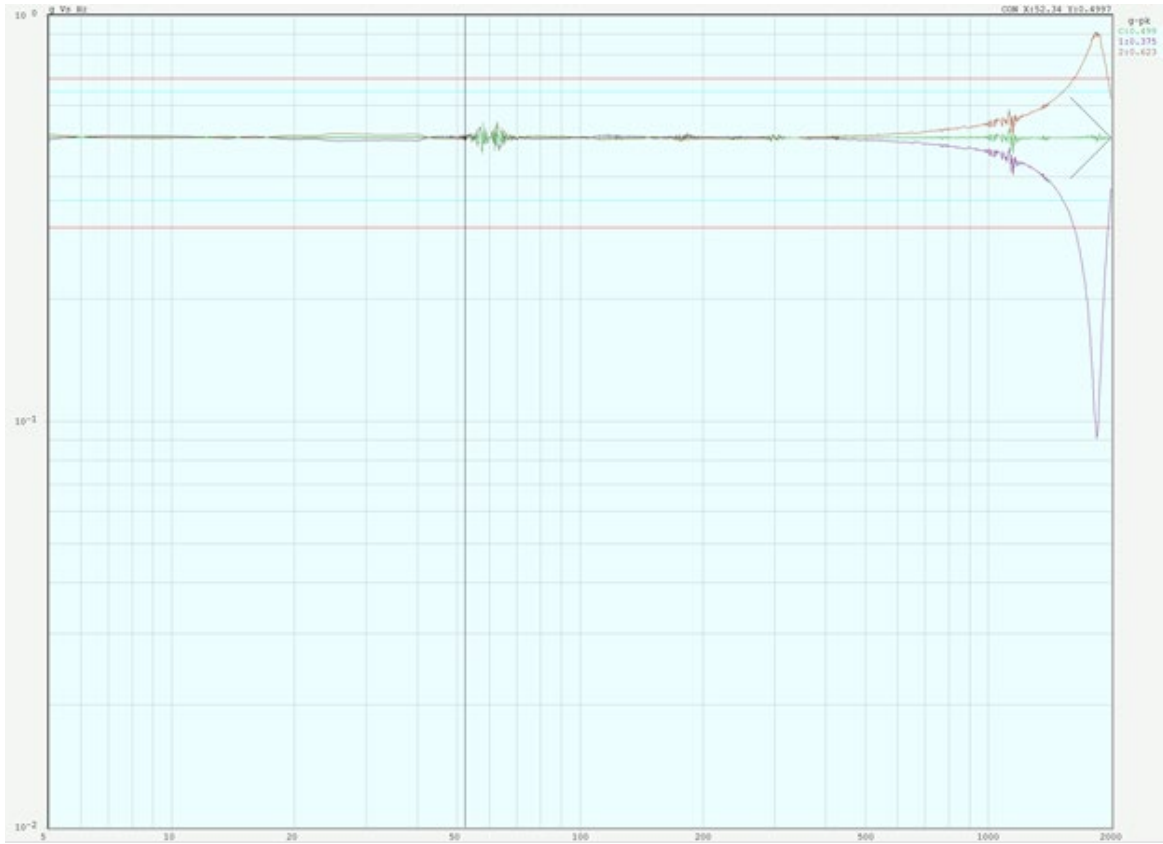
Y axis sine sweep fixture and backplane

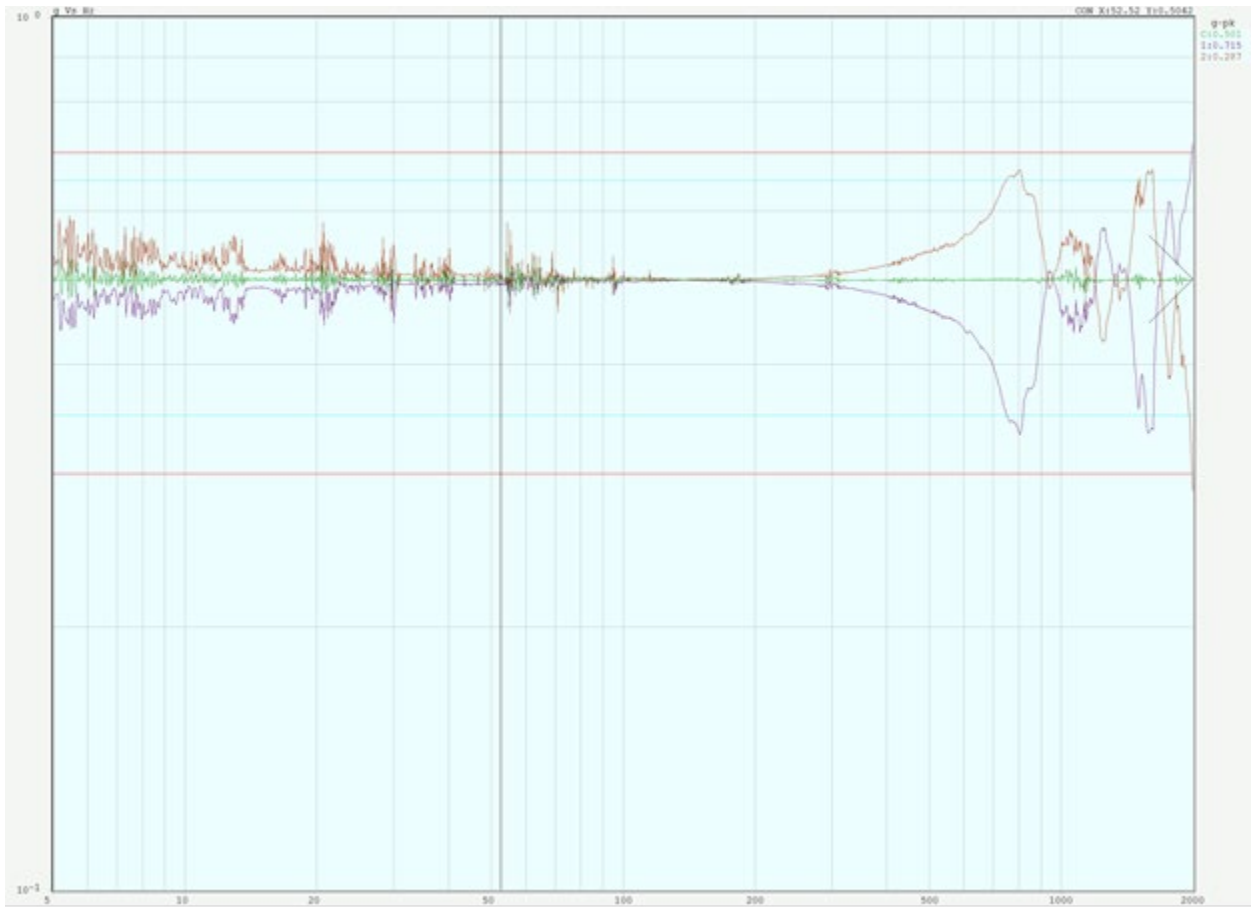
Y axis sine sweep whole assembly

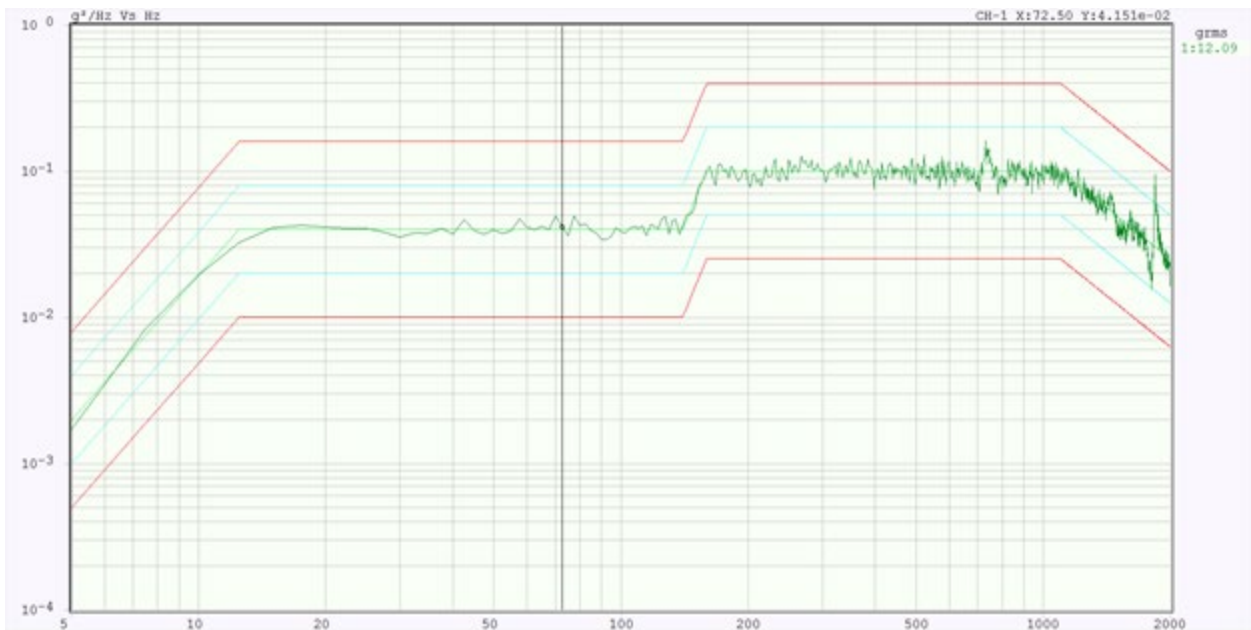
Z Axis Random First Run
