| <b>ENGINEERING SUMMARY<br/>REPORT</b> | Report # | ESR-9553 |
| Evaluation of RVPX product line to VITA 46 standards | Revision #: | 4 |

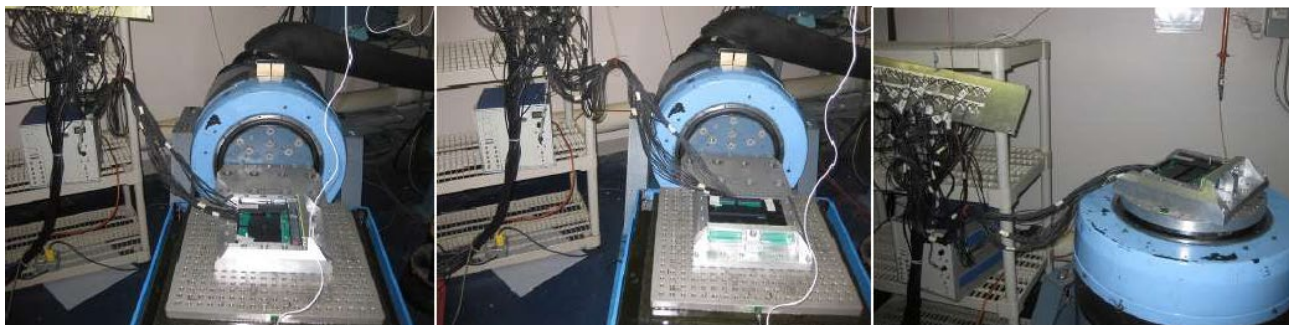
Figure 6: Vibration test set-up

- 4.5.1** Samples were subjected to a 10 minute sine vibration sweep of 5 g between 50 and 2000 Hz to identify their resonant frequencies and transmissibilities. Response accelerometers were located at the areas of highest displacement/acceleration of the first 3 vibration modes, e.g. center of middle rib. The frequency and transmissibility data was compared to data from typical 6U x 160mm conduction cooled product to ensure similarity.

- 4.5.2** Samples underwent different random vibration tests, according to MIL-STD-1344A, Method 2005.1. The first sample was tested to Test Condition V, letter D (0.1 G<sup>2</sup>/Hz max., 1.5 hours per axis) as a minimum requirement of VITA 46. The second sample was tested to further explore the connector capability. The vibration level was applied as a step stress, i.e. 0.125 G<sup>2</sup>/Hz for 15 minutes, 0.15 G<sup>2</sup>/Hz for 15 minutes, 0.175 G<sup>2</sup>/Hz for 15 minutes, and 0.2 G<sup>2</sup>/Hz for 45 minutes, for a total duration of 1.5 hours.

No discontinuities were detected during vibration testing. Following vibration testing, no cracks, breaks, or loose parts on the specimens were visible.

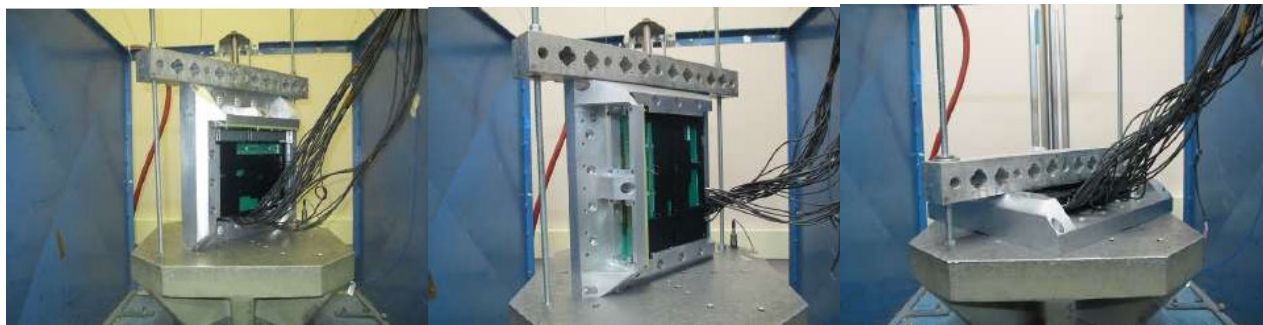
Figure 7: Mechanical Shock test set-up

Each sample underwent shock following MIL-STD-1344A, Method 2004.1, Test Condition A (1/2 sine, 50 g in perpendicular axis, 80 g in other axes, 11 ms, 3 hits from both directions in each of 3 mutually perpendicular axes for a total of 18 hits).

No discontinuities were detected during mechanical shock testing. Following mechanical shock testing, no cracks, breaks, or loose parts on the specimens were visible.

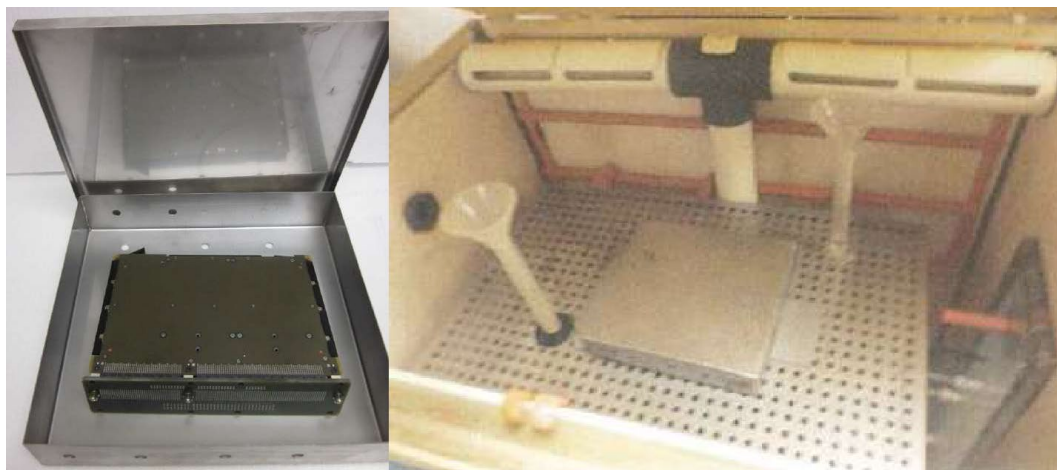
Figure 8: Salt Fog with SO<sub>2</sub> test set-up

One Group D sample underwent Salt Fog with SO<sub>2</sub> per ASTM G85 (Annex A4, Cycle A4.4.4.1). The test sample was exposed in the mated condition in a sheet metal container.

No evidence of physical damage was visible as a result of exposure.
