# National Technical Systems Test Report for Environmental and Dynamics Testing of the Media Converter

Amphenol Aerospace | 191 Delaware Ave | Sidney, NY 13838

National Technical Systems | 36 Gilbert Street South | Tinton Falls, NJ 07701 | 732-936-0800 | [www.nts.com](http://www.nts.com)

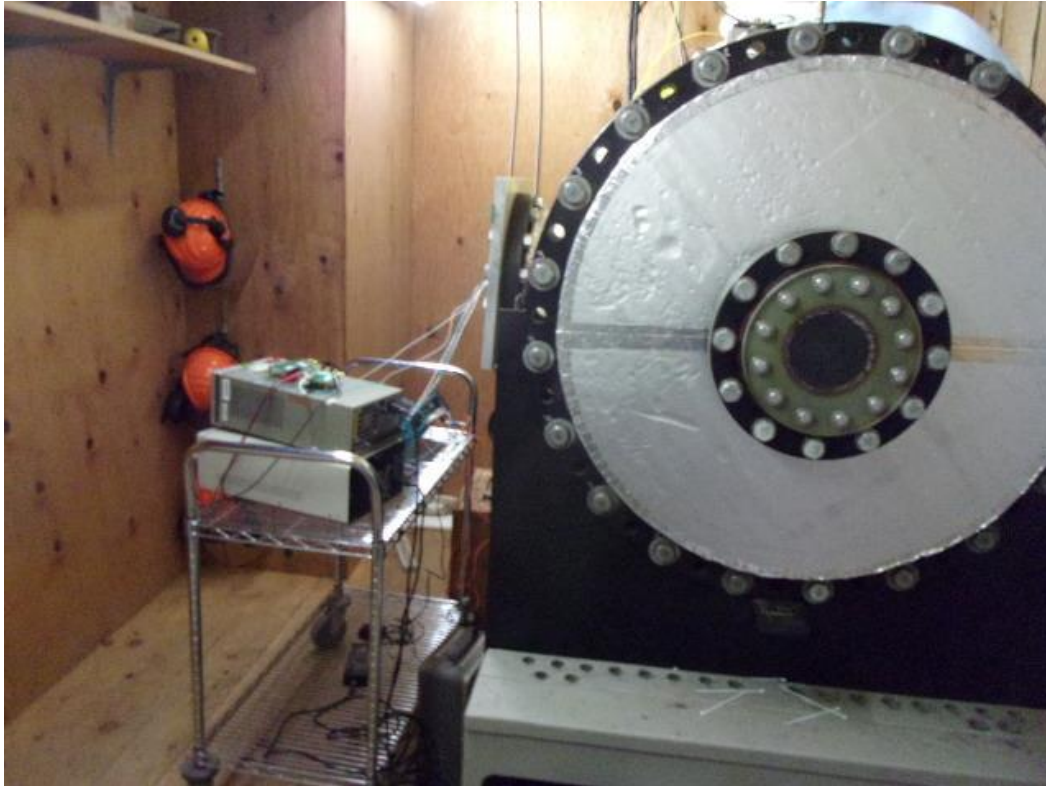
Explosive Atmosphere Setup

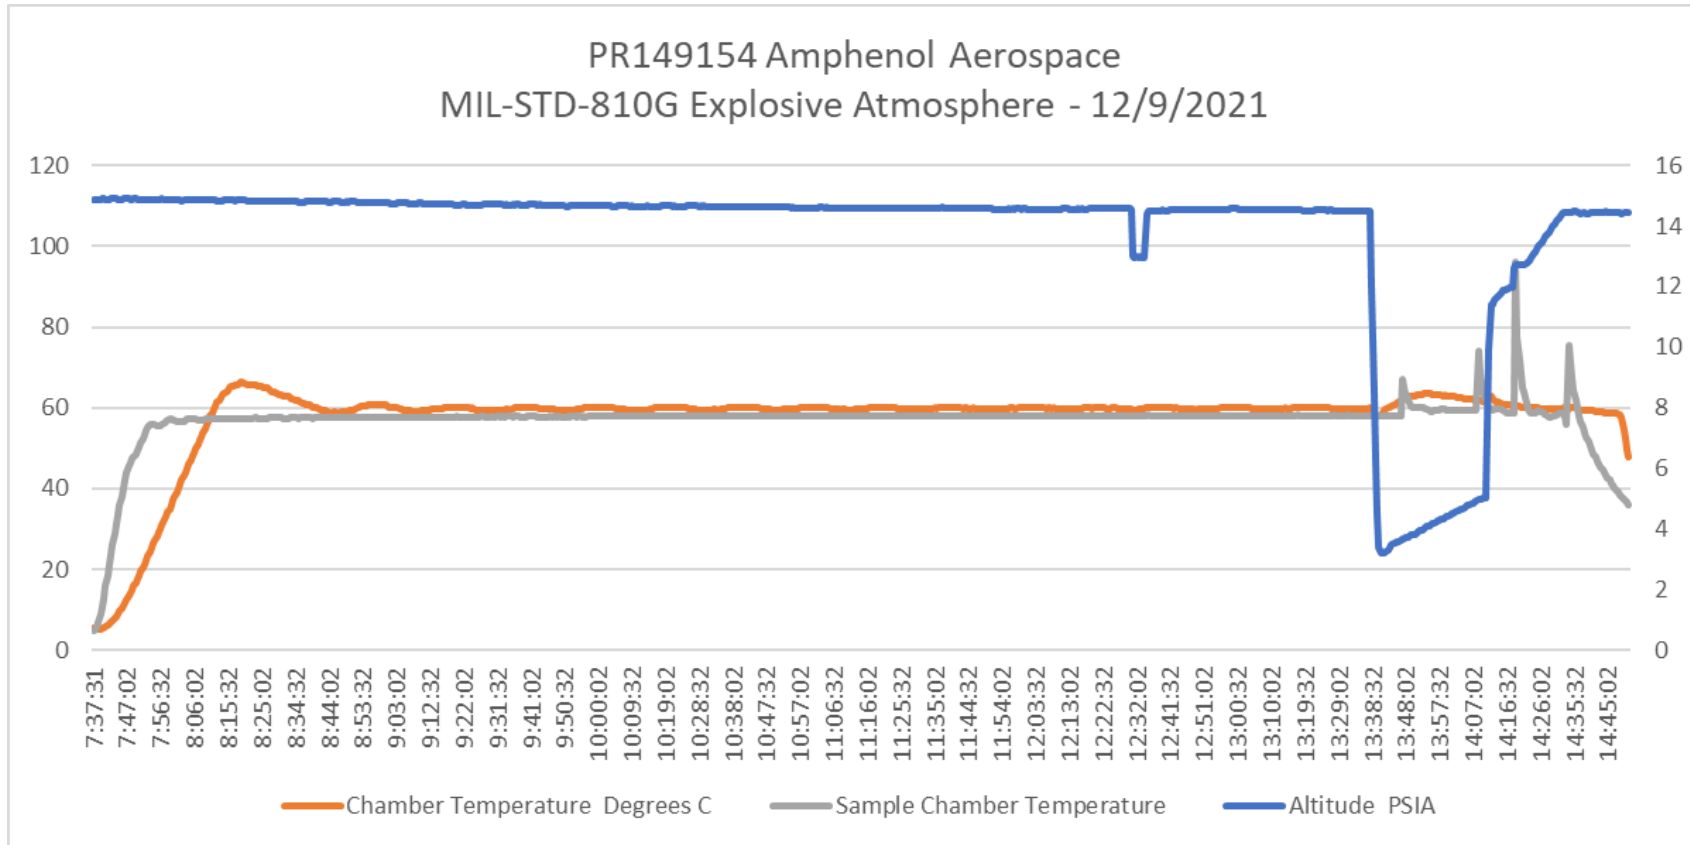
DATE /TIME	TEST ALT	Chamber Temp (C)	Specimen Temp (C)	Wall Temp (C)	Specimen Operating	COMMENTS (Insure Fuel Quantity is added here)	INIT
12/9/2021	Site	60C	60C	60C	Yes	144 Milliliters of Hexane added (205ml total)	BP
12/9/2021	30kft	60C	60C	60C	Yes	61 Milliliters of Hexane added	BP

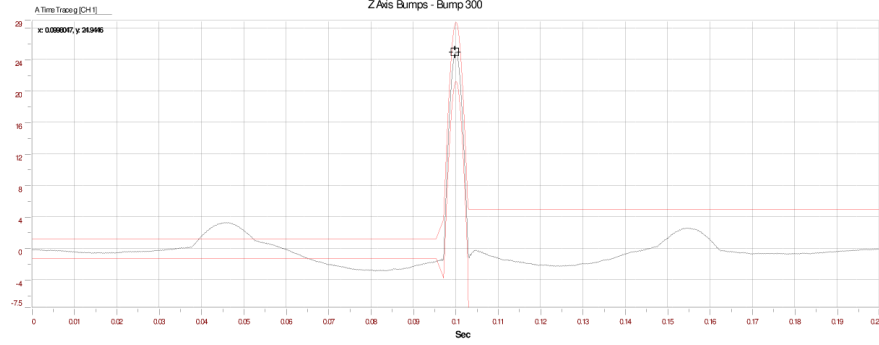
Z Axis Bumps - Bump 300

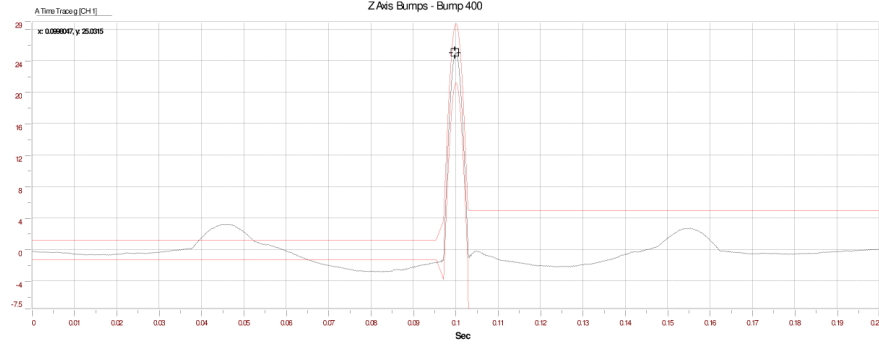
Z Axis Bumps - Bump 400

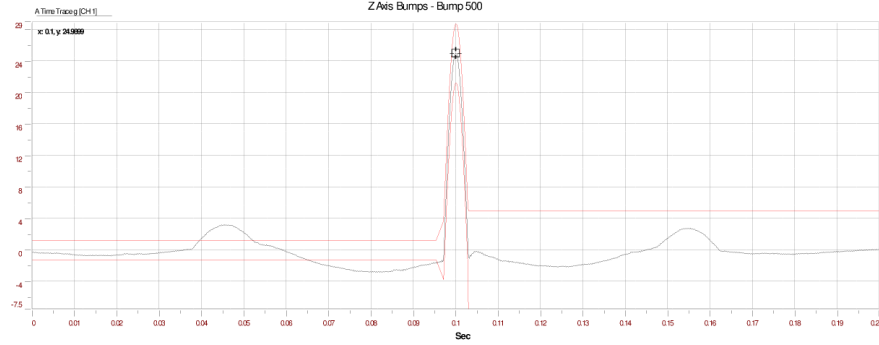
Z Axis Bumps - Bump 500

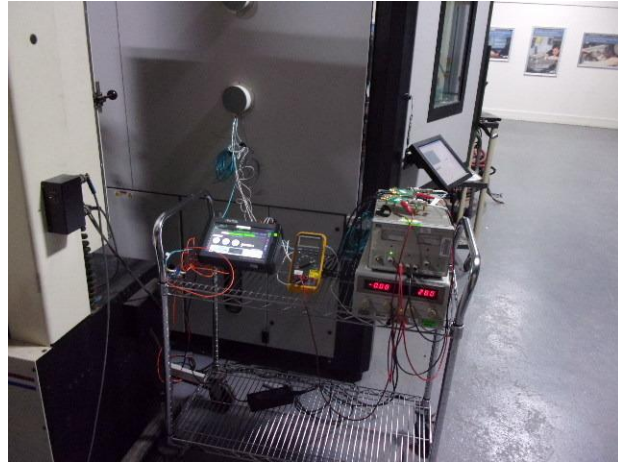
Humidity Setup

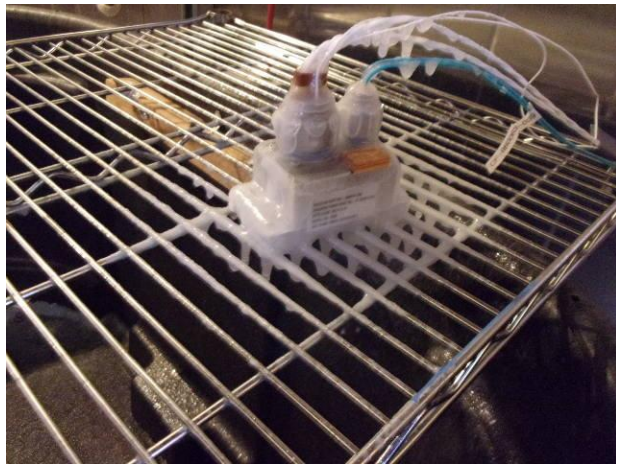
6mm of Ice
