<h1>ENGINEERING SUMMARY REPORT</h1>	Report #	ESR-9553
	EWOM #	N/A
	CLT #	N/A
<p>Evaluation of RVPX product line to VITA 46 standards</p>	Revision #:	4
	Publish Date	
	3/8/2016

Testing was performed on Amphenol's R-VPX Ruggedized VITA 46 connector to determine its conformance to the requirements of VITA 46. Testing also included intermatability with current VITA 46 compliant connectors offered by another connector manufacturer.

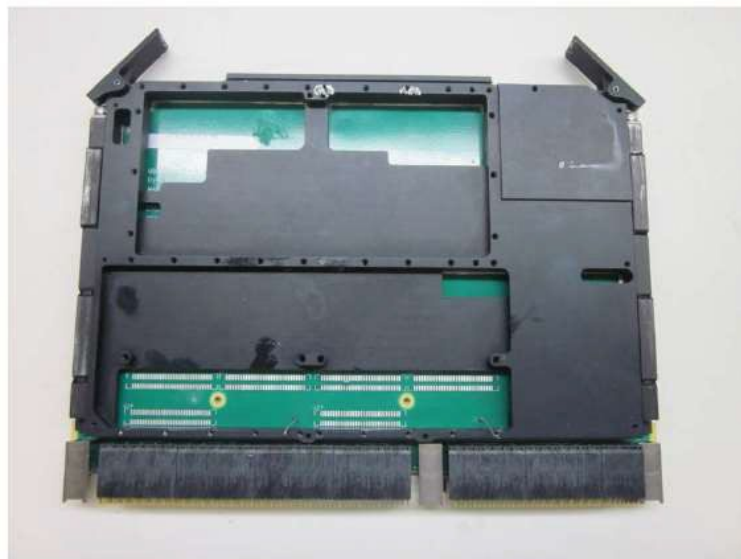
Figure 1: Typical Test Sample

Test specimens were representative of normal production lots. Specimens identified with the following part numbers were used for test

Sample	Part Number	Description
VITA 46 6U Daughtercard Amphenol	RVPX-P08VM2	Right angle daughtercard 8 pos. end
	RVPX-P16DM2	Right angle daughtercard 16 pos. center
	RVPX-HMM6	Right angle daughtercard guide module
VITA 46 6U Backplane Amphenol	RVPX-J08EM2	Vertical receptacle backplane 8 pos. end
	RVPX-J16MM2	Vertical receptacle backplane 16 pos. middle
	RVPX-J16EM2	Vertical receptacle backplane 16 pos. end
	RVPX-HPM-2	Keyed guide pin machined
VITA 46 6U Daughtercard	TE Connectivity RT2-R	Right angle daughtercard 8 pos. end
	TE Connectivity RT2-R	Right angle daughtercard 16 pos. center
	TE Connectivity RT2-R	Right angle daughtercard guide module
VITA 46 6U Backplane	TE Connectivity RT2-R	Vertical receptacle backplane 8 pos. end
	TE Connectivity RT2-R	Vertical receptacle backplane 16 pos. middle
	TE Connectivity RT2-R	Vertical receptacle backplane 16 pos. end
	TE Connectivity	Keyed guide pin machined

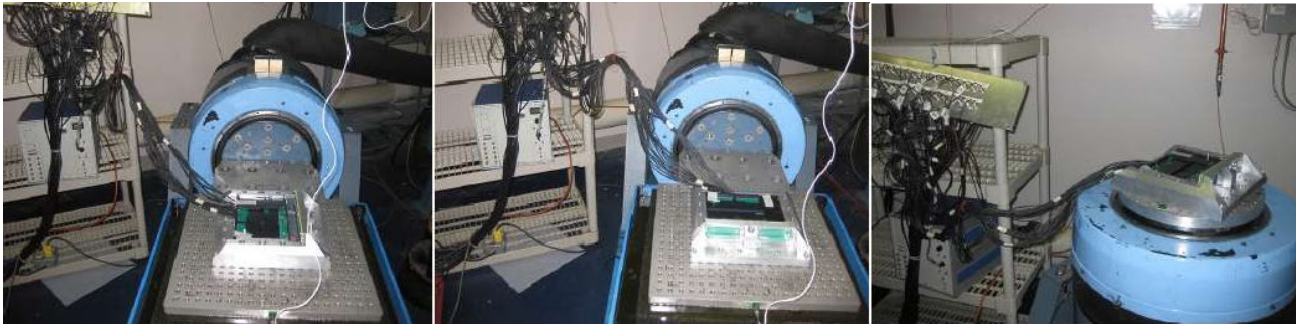
Figure 6: Vibration test set-up

**4.5.1** Samples were subjected to a 10 minute sine vibration sweep of 5 g between 50 and 2000 Hz to identify their resonant frequencies and transmissibilities. Response accelerometers were located at the areas of highest displacement/acceleration of the first 3 vibration modes, e.g. center of middle rib. The frequency and transmissibility data was compared to data from typical 6U x 160mm conduction cooled product to ensure similarity.

**4.5.2** Samples underwent different random vibration tests, according to MIL-STD-1344A, Method 2005.1. The first sample was tested to Test Condition V, letter D (0.1 G<sup>2</sup>/Hz max., 1.5 hours per axis) as a minimum requirement of VITA 46. The second sample was tested to further explore the connector capability. The vibration level was applied as a step stress, i.e. 0.125 G<sup>2</sup>/Hz for 15 minutes, 0.15 G<sup>2</sup>/Hz for 15 minutes, 0.175 G<sup>2</sup>/Hz for 15 minutes, and 0.2 G<sup>2</sup>/Hz for 45 minutes, for a total duration of 1.5 hours.

No discontinuities were detected during vibration testing. Following vibration testing, no cracks, breaks, or loose parts on the specimens were visible.

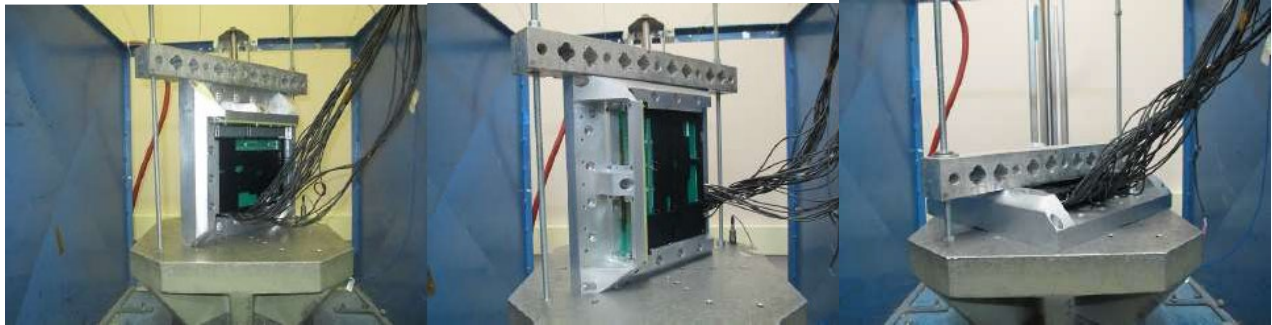
Figure 7: Mechanical Shock test set-up

Each sample underwent shock following MIL-STD-1344A, Method 2004.1, Test Condition A (1/2 sine, 50 g in perpendicular axis, 80 g in other axes, 11 ms, 3 hits from both directions in each of 3 mutually perpendicular axes for a total of 18 hits).

No discontinuities were detected during mechanical shock testing. Following mechanical shock testing, no cracks, breaks, or loose parts on the specimens were visible.

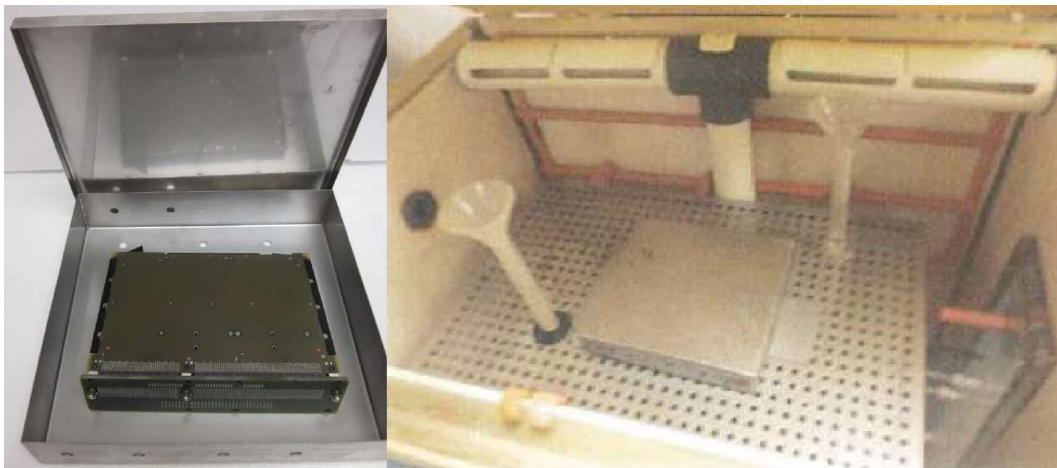
Figure 8: Salt Fog with SO<sub>2</sub> test set-up

One Group D sample underwent Salt Fog with SO<sub>2</sub> per ASTM G85 (Annex A4, Cycle A4.4.4.1). The test sample was exposed in the mated condition in a sheet metal container.

No evidence of physical damage was visible as a result of exposure.
