# ENGINEERING REPORT

**REPORT NUMBER**  
C1-1179

**TITLE: QUALIFICATION OF LOW FORCE  
RUGGED VME64X BACKPLANE/MODULE  
CONNECTORS TO BS-VME64X-AA REV PA 11  
SPECIFICATION SUBSET**

**REPORT TYPE**  
Qualification Summary

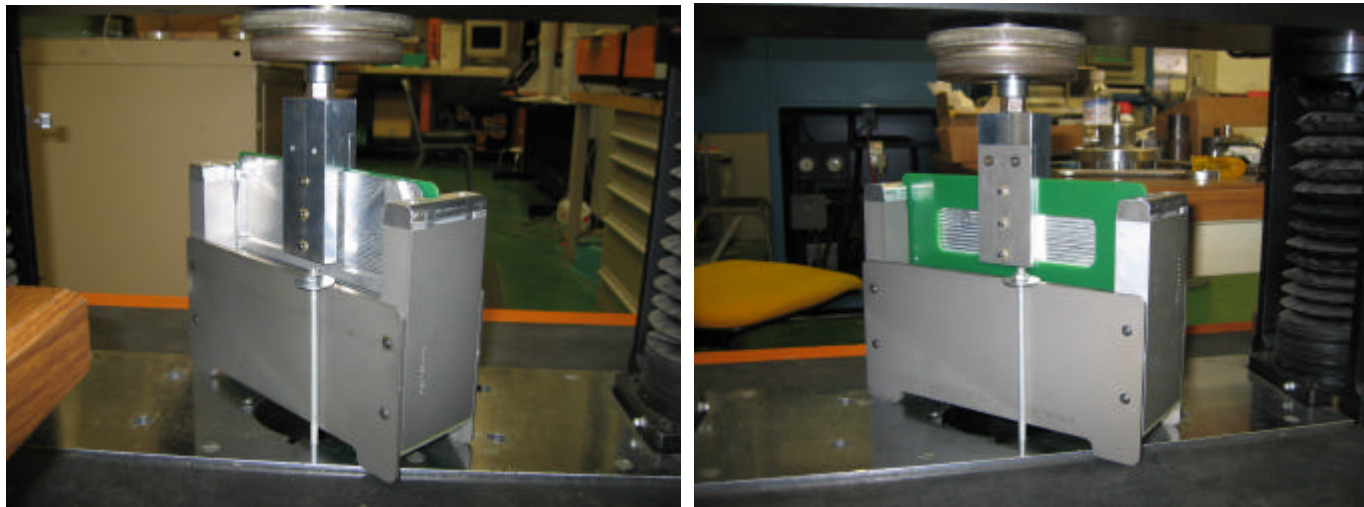
**FIGURE 1. INITIAL MATING FORCE TEST SET-UP.**

Mating and unmating forces were measured prior to any other engagement cycles so as to capture initial mating force values.. The initial mating force testing was conducted with the module card engaging into a single slot rack, which was installed on the backplane test board to guide the connectors into engagement (see Figure 1). This approach was extremely sensitive to test set-up, and easily introduced erroneously high mating force values due to uncontrolled friction between the rack and the module test sample. Unfortunately this was not discovered until after the initial mating cycle had been completed for Sample 1. The data has been compiled in Table 6.

After the initial testing that was described in 8.1.3, a new test technique was developed. As depicted in Figure 3, the single slot rack was completely eliminated, thereby eliminating the frictional force of the module card in the slot. In an attempt to mitigate inaccuracy due to set up variations from cycle to cycle, five readings were recorded, and the average listed in Table 8.

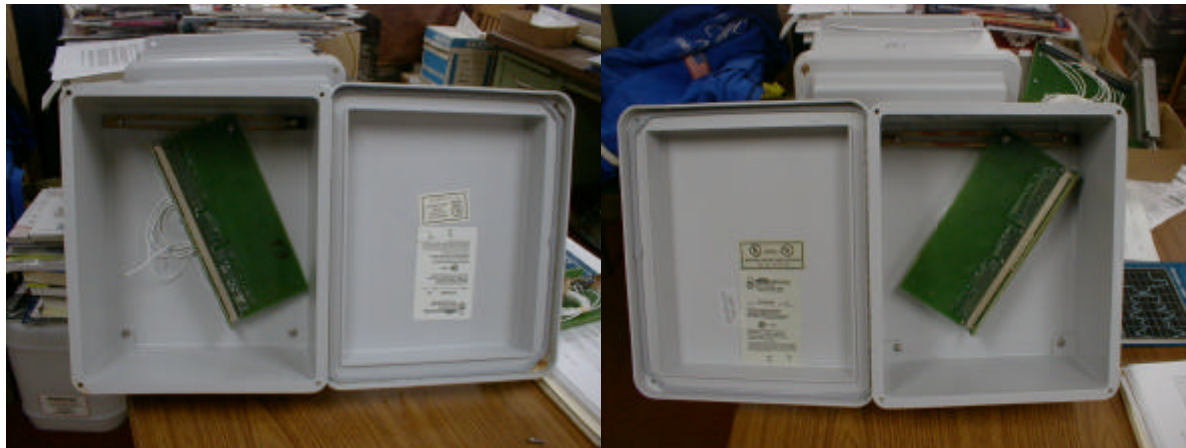
**FIGURE 4. NEMA TYPE 4X ENCLOSURE USED FOR SALT ATMOSPHERE TESTING**

Samples were each suspended in a NEMA Type 4X electrical enclosure that was 10" wide, 12 " tall and 6" deep (see Figure 4). Enclosures had 2, 1/8" holes drilled into the bottom to simulate the drain holes in the connector's environment application. After 500 hours suspended in salt atmosphere, enclosures were removed and samples examined. Condensed water droplets and salt deposits were found on each sample. Samples were rinsed in warm tap water and salt deposits were brushed off the circuit boards with a soft bristle brush. The connectors were not unmated. After baking dry in an oven at 50C for one hour, boards were tested for Low Level Contact Resistance and Contact Resistance. Visual inspection showed no evidence of exposure of base metals, pitting, or porosity. There was no cracking or delaminating of finishes or components.

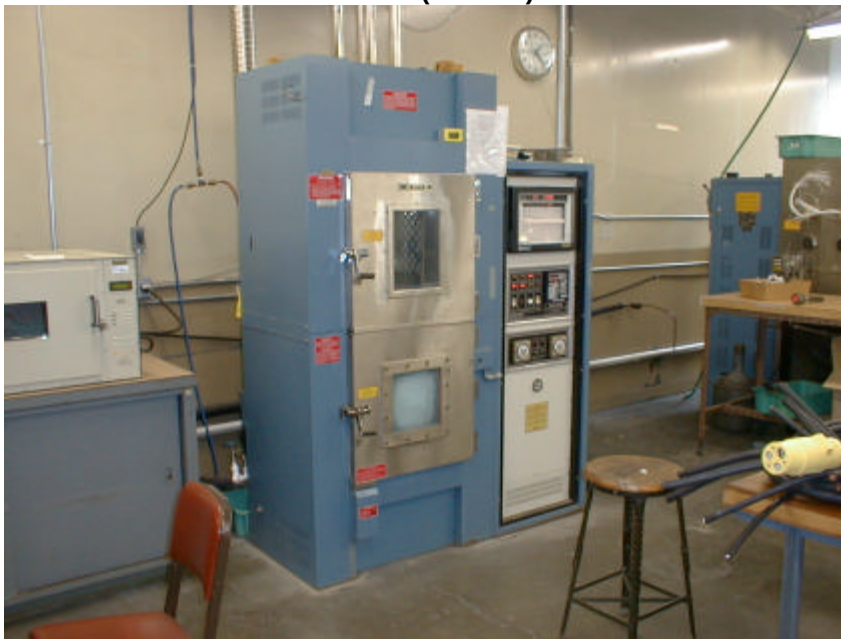
**FIGURE 6. THERMAL CYCLING (SHOCK) CHAMBER**

Group three samples were placed into the basket of the Thermal Cycling Chamber in the mated condition as shown in Figure 6 and 7. Samples were exposed to  $-65^{\circ}\text{C}$  to  $+125^{\circ}\text{C}$  with a less than 5 minute transfer time and one hour dwells for 5 cycles. The samples were not mated and unmated at the temperature extremes during the fifth cycle. Instead a sixth cycle was run where the samples were individually brought down to  $-65^{\circ}\text{C}$  in the unmated state, then
